North Kingstown Town Hall & Annex

Building Improvements Feasibility Study 2016

Prepared By:
Aharonian & Associates, Inc.
310 George Washington Hwy
Smithfield, RI 02917

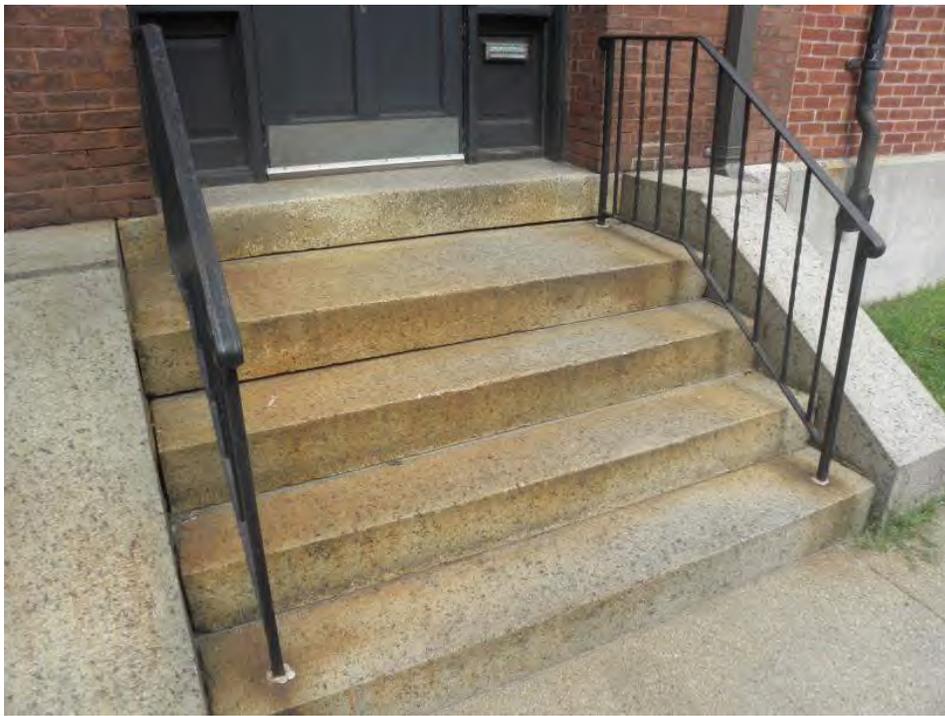
Photo 17

The exterior of the original building is in fairly good condition, considering its age. There are areas where repointing of the brick is required. Mortar was missing from the joints of the granite stairs at the front and east side of the building. The granite stairs on the east side have settled slightly toward the rear of the buildings. There is a downspout from the roof that enters the ground adjacent to the settled side of the stairs refer to photos 17 to 20.

Mortar missing from the joints at the front exterior granite stairs.

1. The exterior brickwork should be repointed where required and mortar should be replaced where it is missing.
2. The exterior granite stairs at the east side entrance should be removed and reconstructed, because they have settled and because water is getting into the basement and deteriorating the foundation wall at that location. When the stairs are removed, the drainage of the adjacent downspout below grade should be reviewed to make sure it is not contributing to the water infiltration into the basement.

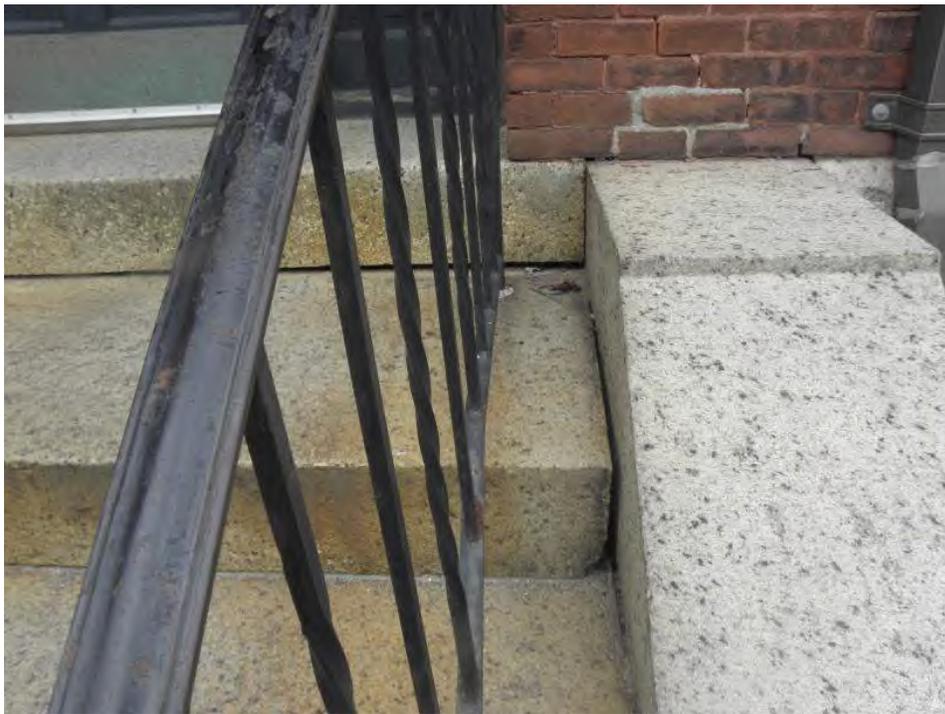
Photo 18

Mortar missing from the joints at the east side granite stairs. The stairs settled toward the rear, at right in photo.

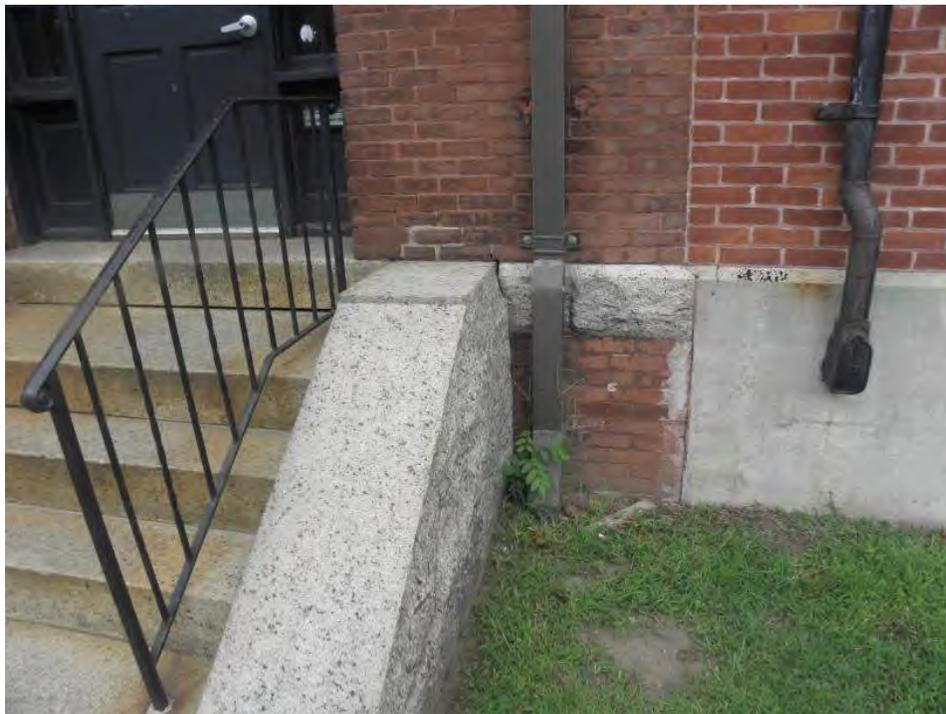
Photo 19

Mortar missing from the joints at the east side granite stairs. The stairs settled toward the rear, at right in photo.

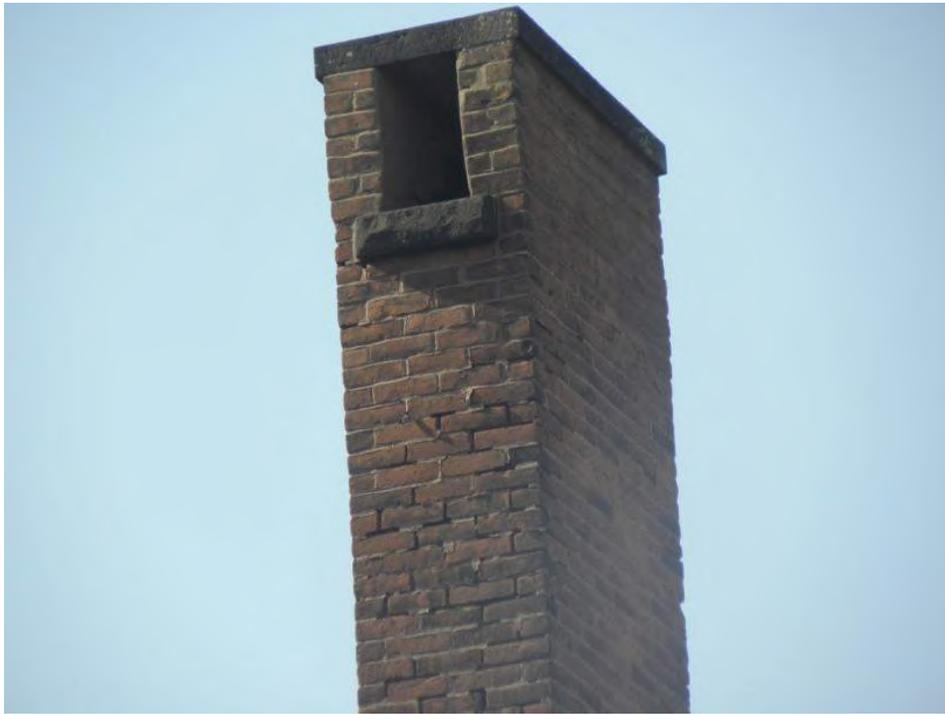
Photo 23

Two brick chimneys on the west side of the original building.

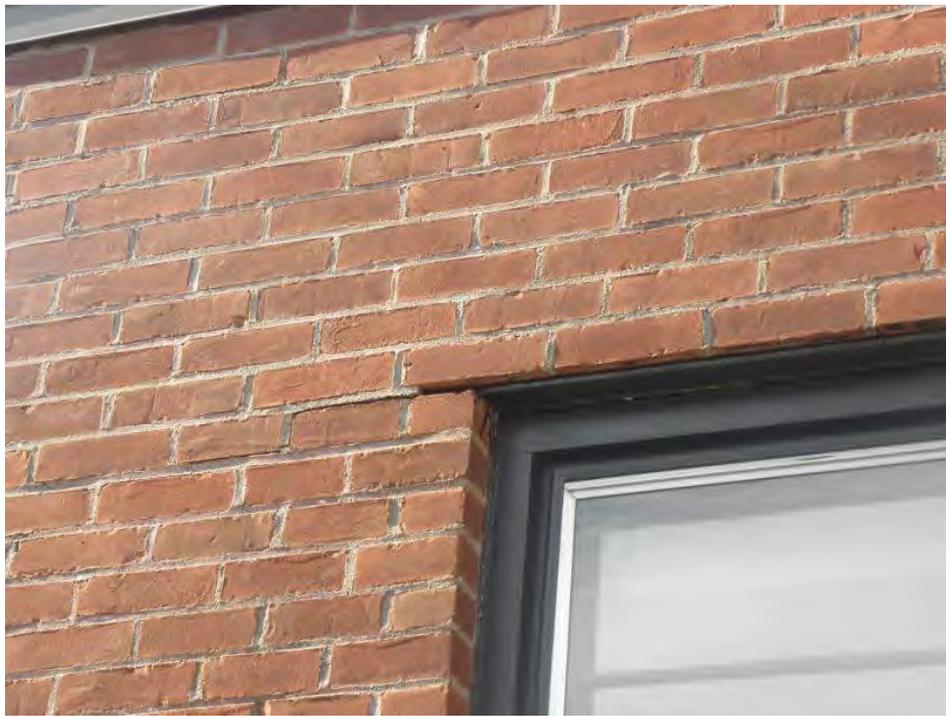
Photo 25

There were several vertical shrinkage cracks in the concrete foundation walls of the rear addition. The steel angle lintels above the rear addition windows and the west addition vent have started to rust and crack the mortar joints in the brick veneer at the top corners of the window and vent openings, refer to photos 25, 26, and 27.

Typical vertical shrinkage crack in the foundation of the rear addition.

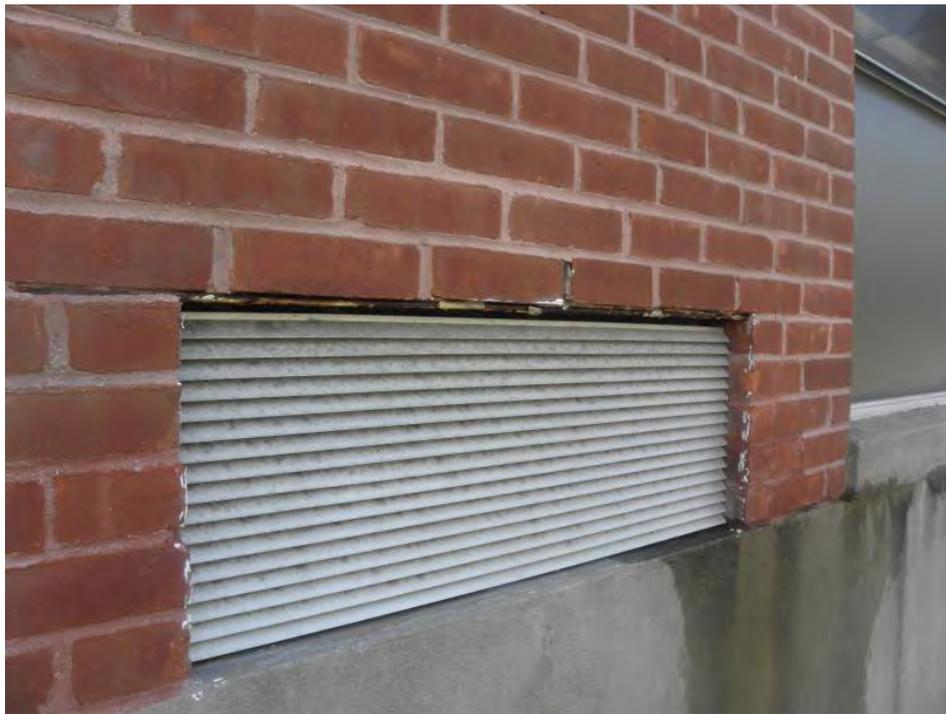
Photo 26

Cracked mortar joint at top corner of the 1950's addition window, where the steel angle lintel has rusted and expanded.

3. The rusted steel angle lintels over the windows and vent in the additions should be removed and replaced with galvanized steel lintels.
4. Deteriorated and spalled areas of the concrete ramp, stairs, and stair walls should be chipped out and patched.

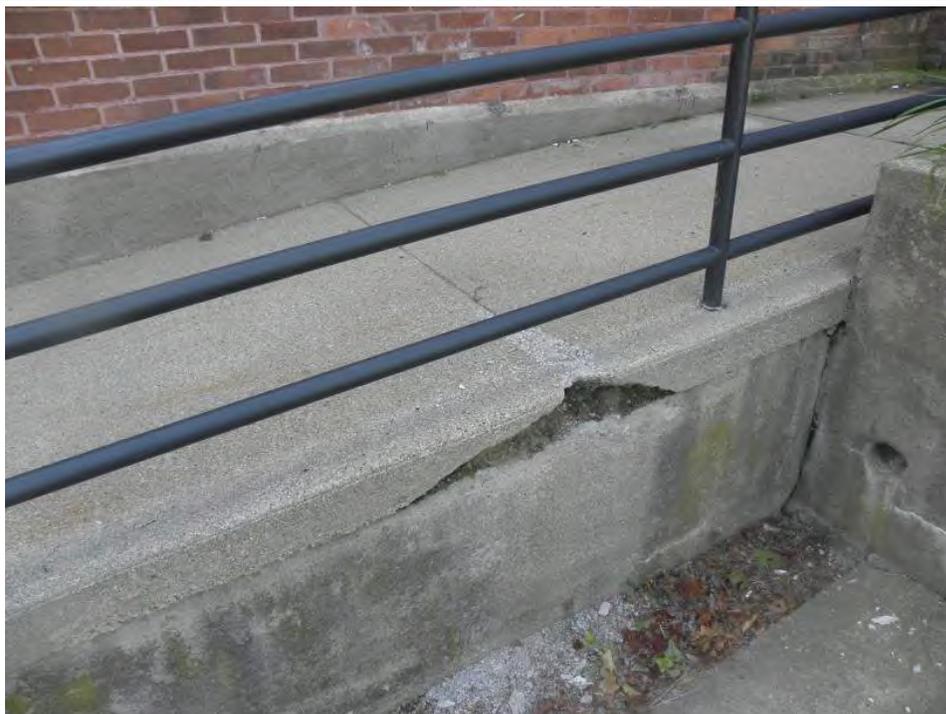
Photo 28

The concrete on areas of the exterior ramp, stairs, and stair walls has started to deteriorate and spall. This will soon present a tripping hazard. One section of the ramp has been previously patched, refer to photos 28 to 32.

Damaged concrete on ramp and exterior stair.

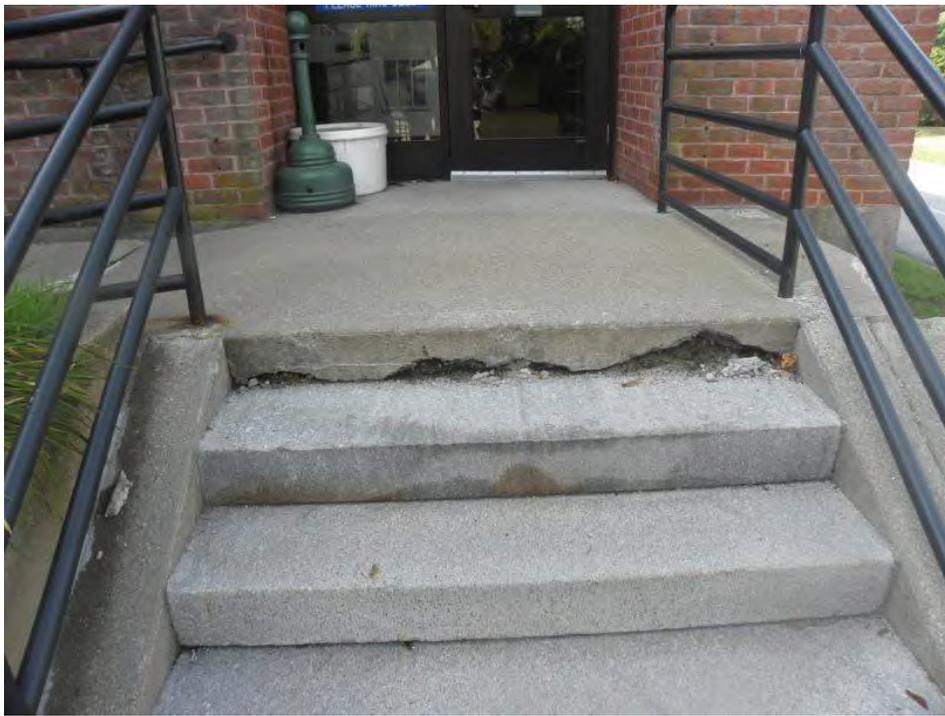
Photo 29

Damaged concrete ramp.

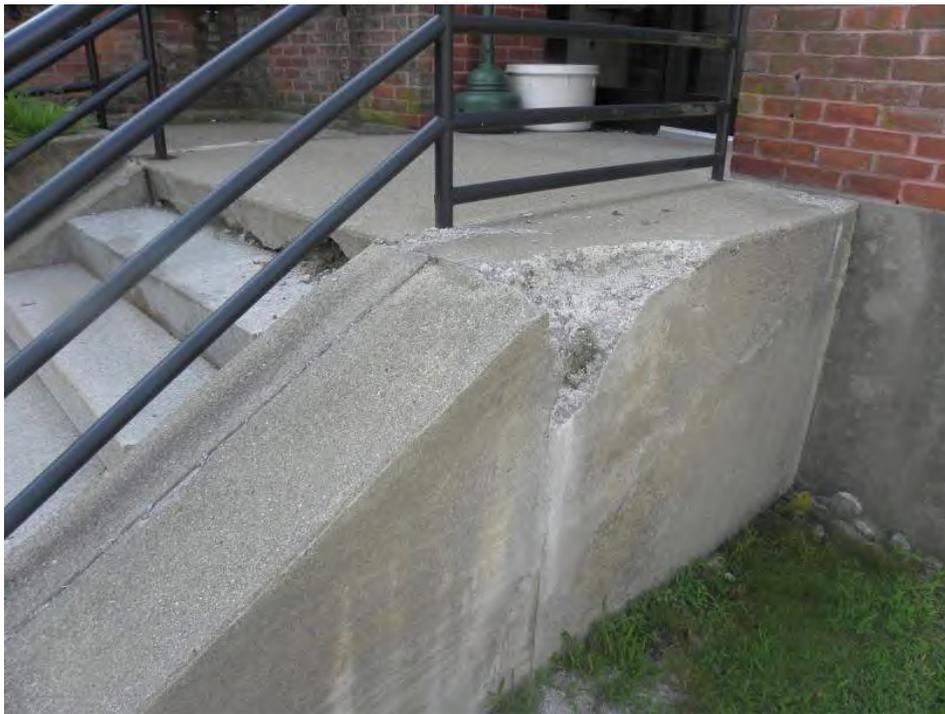
Photo 30

Damaged concrete stair.

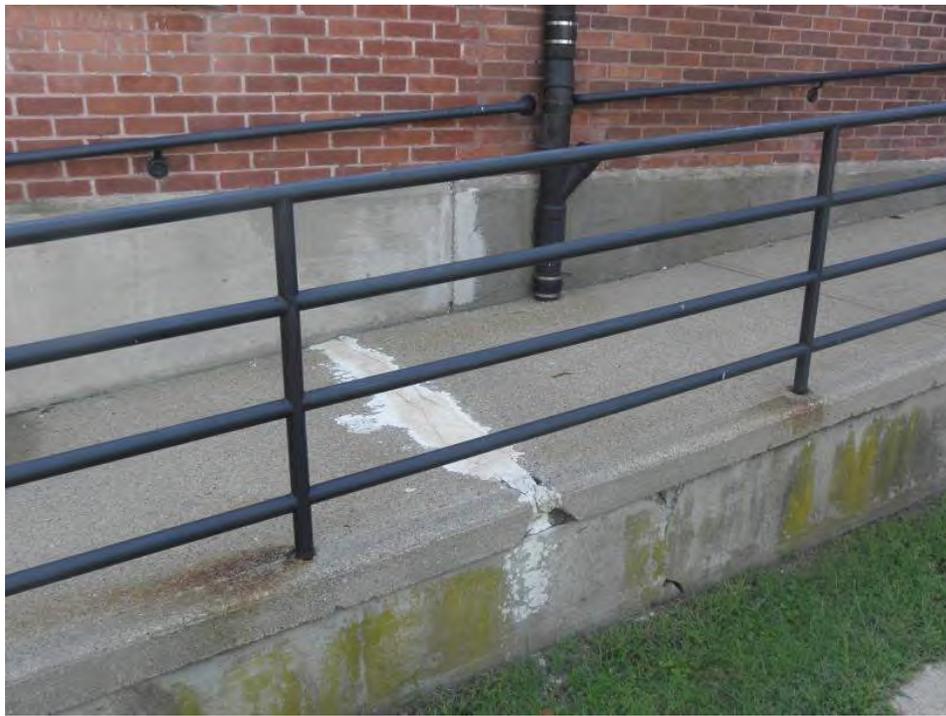
Photo 31

Damaged concrete stair wall.

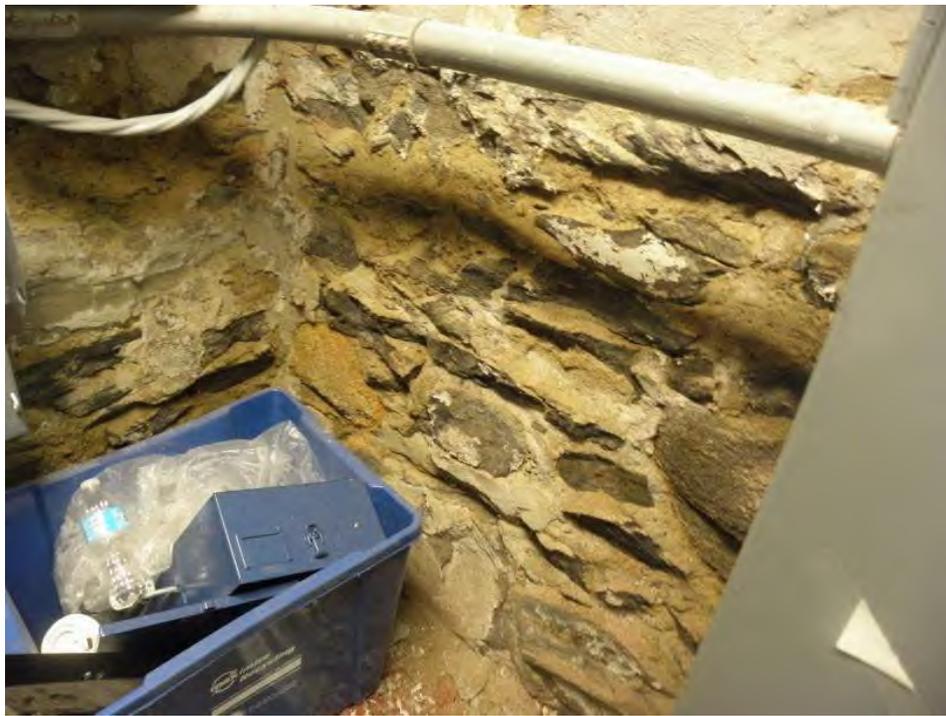
Photo 37

Northeast corner of the foundation wall of the original building. Brick on top and stone on bottom are deteriorated.

Note this area is directly below the east entrance stair and downspout shown in photos 18, 19, and 20.

5. The steel fire escape should be cleaned of rust and repainted if it is going to remain in service.
6. The badly deteriorated section of the basement foundation wall below the east side entrance should be removed and replaced with concrete. This work should be performed in conjunction with reconstruction of the exterior granite stairs. Less severely damaged areas of the basement foundation wall can be patched and repointed.

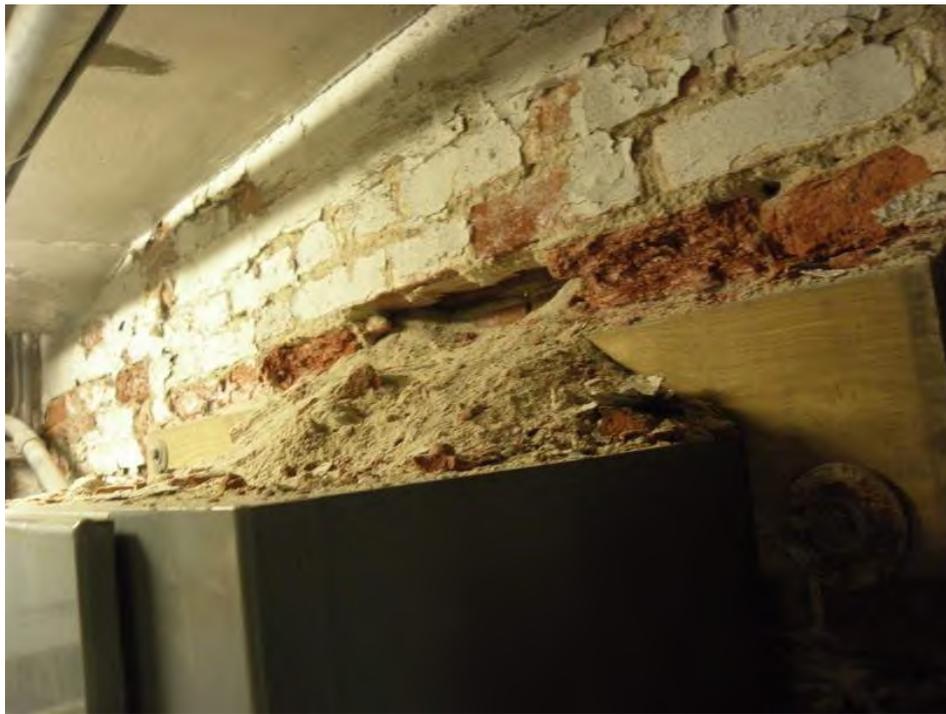
Photo 38

Closer view of area where parging is missing and mortar is sandy and falling out.

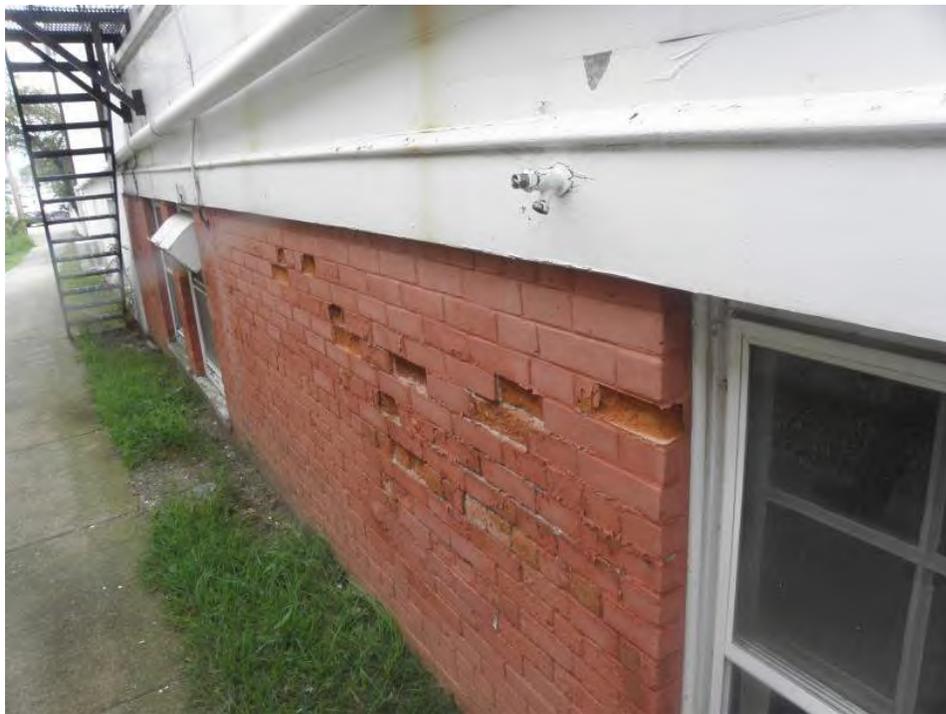
Photo 50

Spalled concrete bricks
on north side of building.

1. The exterior spalled foundation bricks on the north side of the building should be removed and replaced.
2. The rotted pine boards around the front exterior stairs and porch should be removed and replaced.
3. The large wood-framed window wall at the rear of the addition should be removed and replaced.
4. The steel fire escape should be cleaned of rust and repainted if it is to remain in service.
5. The rear deck should be removed and replaced or be replaced with a much smaller deck that provides egress from the rear door.
6. The interior of the brick basement walls should be patched where needed.
7. The two interior brick basement piers should be removed and replaced. Shoring of the beams supported by the piers will be required, when the piers are replaced.

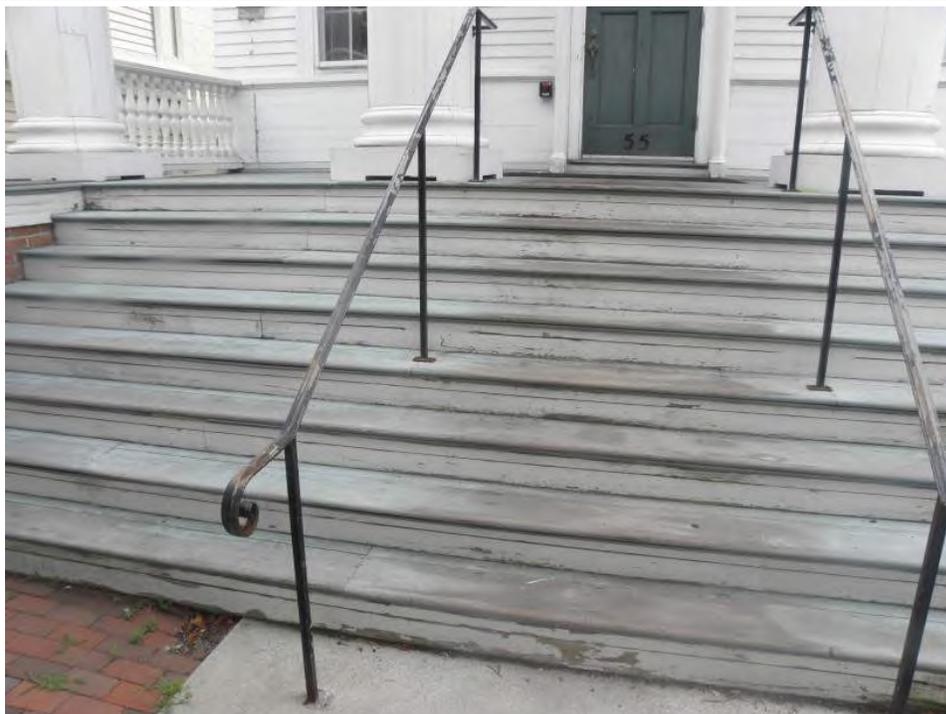
Photo 51

Some deterioration of wood
treads and risers
on the front stairs.

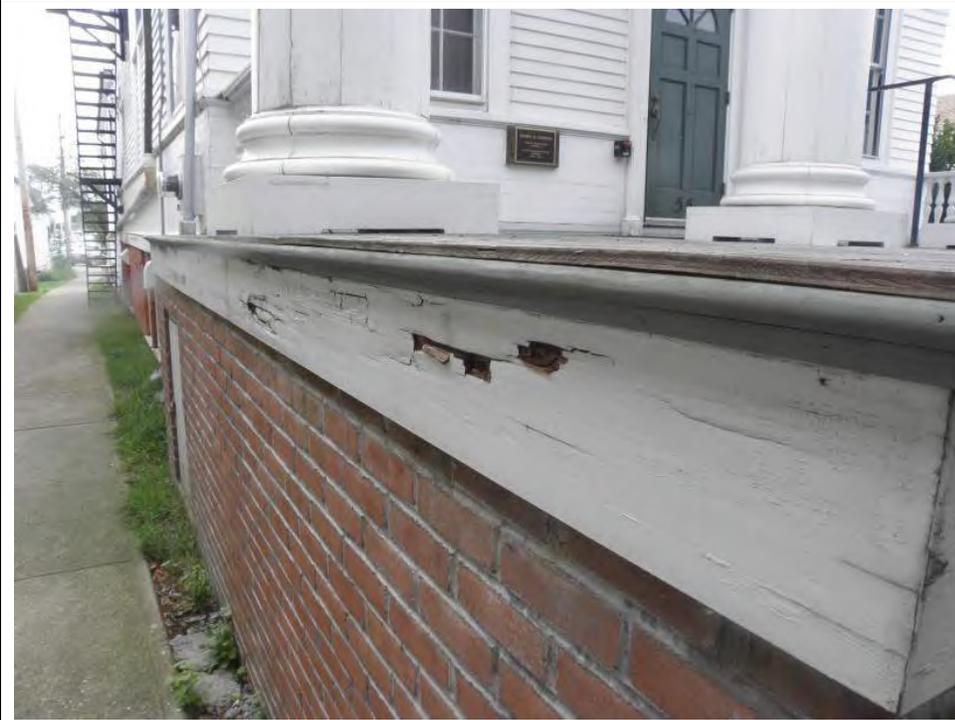
Photo 52

Rotted wood trim at front porch.

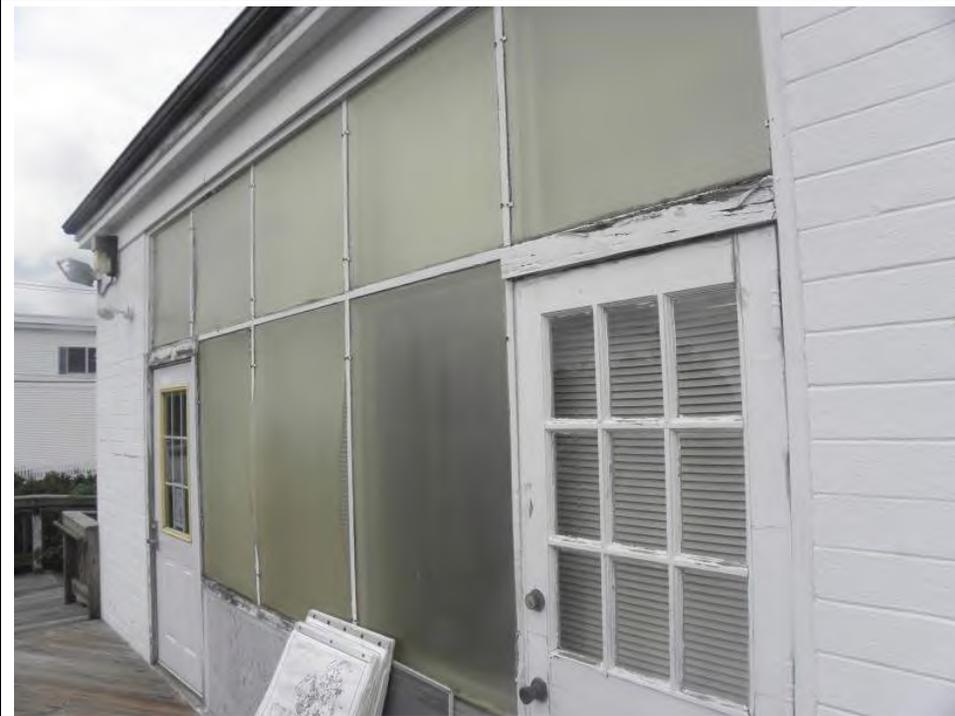
Photo 53

Rear wood-framed window wall. Some of the wood framing is deteriorated.

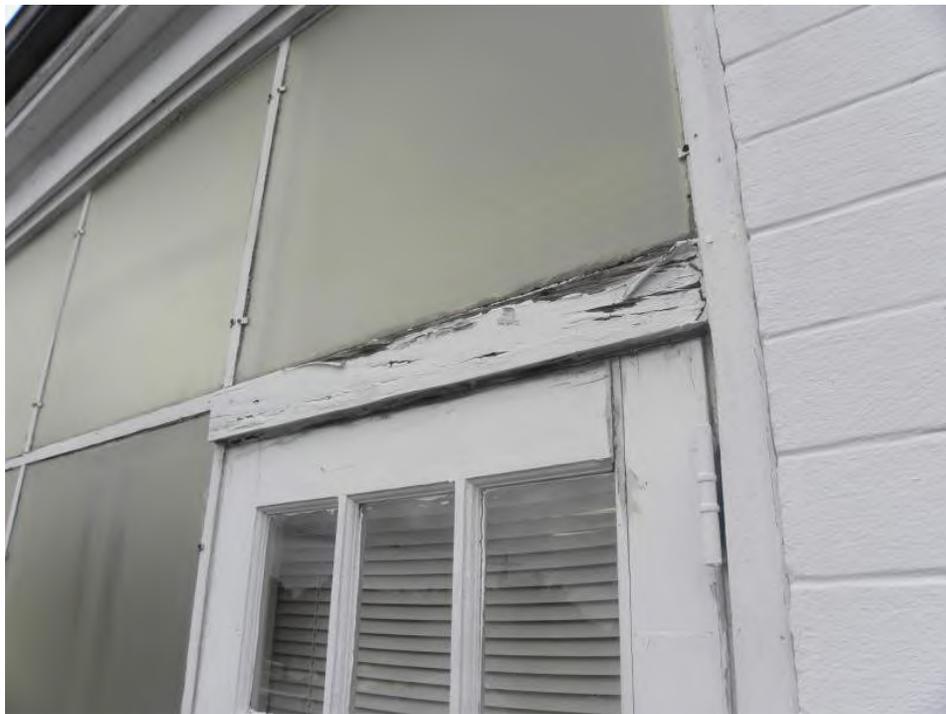
Photo 54

Rotted wood above door in rear window wall.

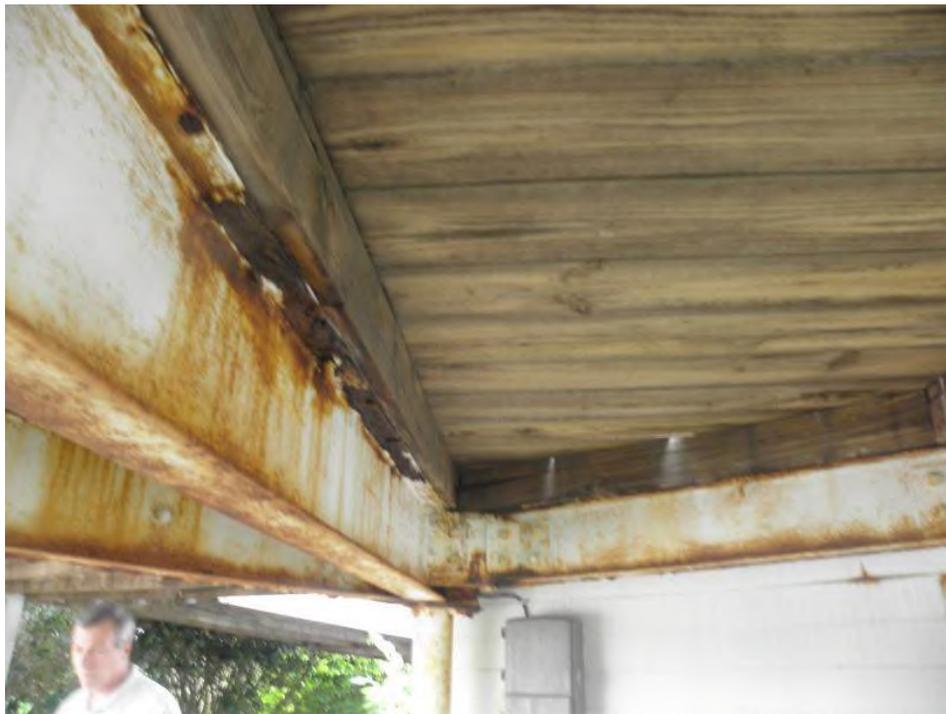
Photo 55

Rusted steel framing below rear deck.

location. The entire steel frame supporting the rear deck has suffered severe loss of structural integrity most likely due to the immediate environment and proximity to the water. Some members have lost as much as fifty percent of their effective mass.

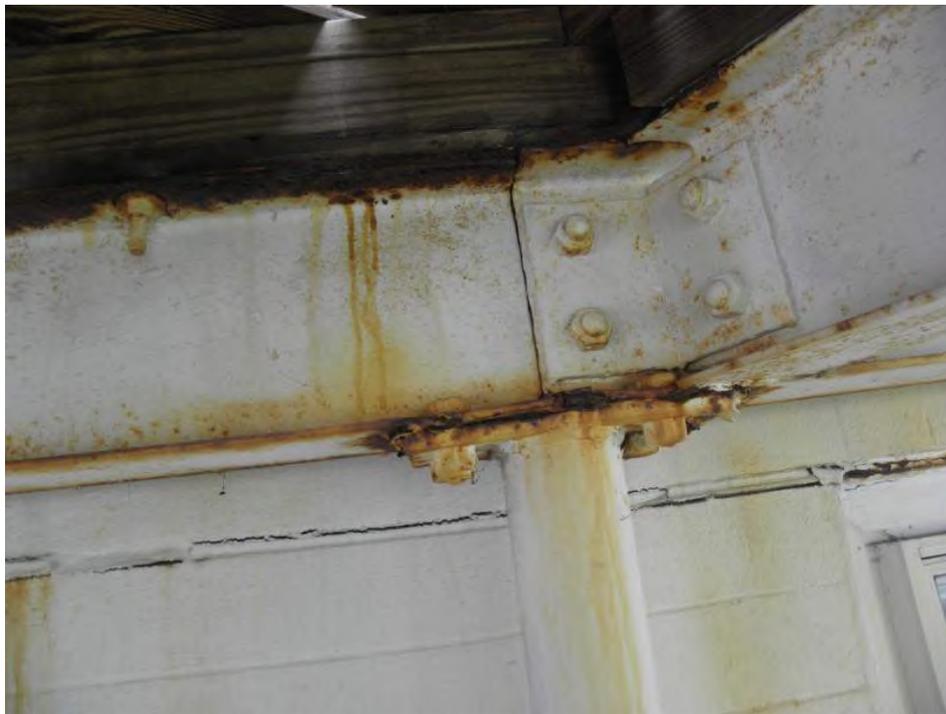
Photo 56
Rusted steel column
cap plate at rear deck.

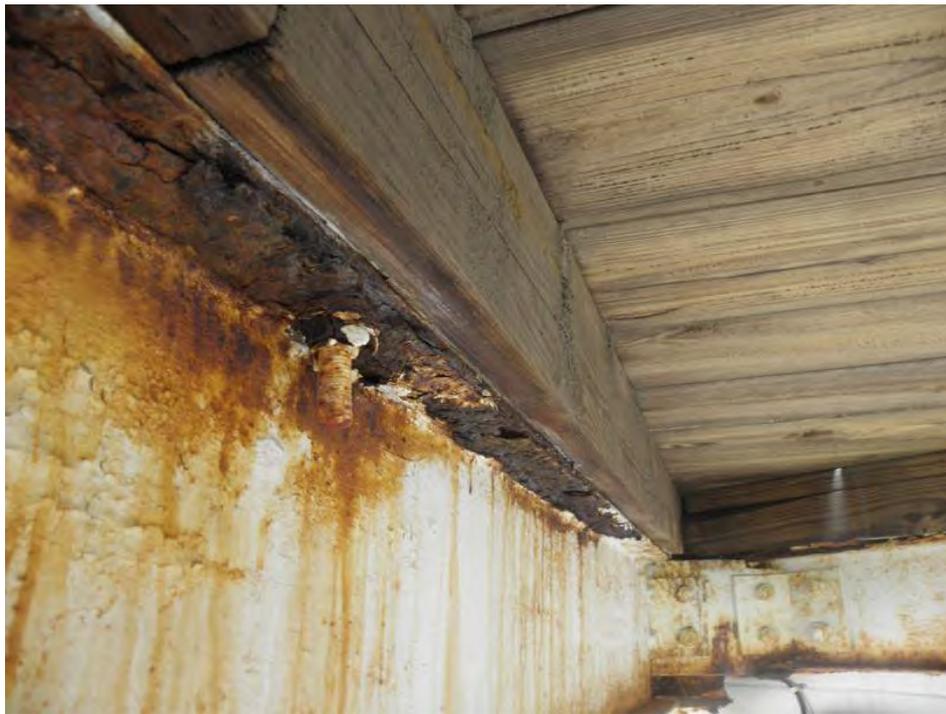
Photo 57
Badly rusted steel beam
at rear deck.

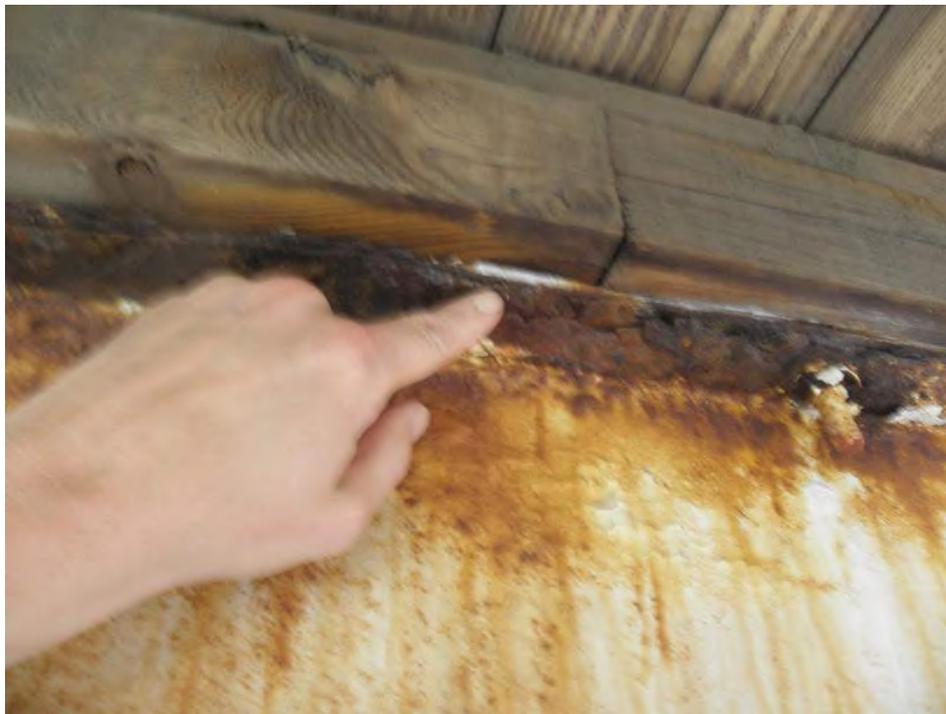
Photo 58

Top flange of steel beam nearly rusted away.

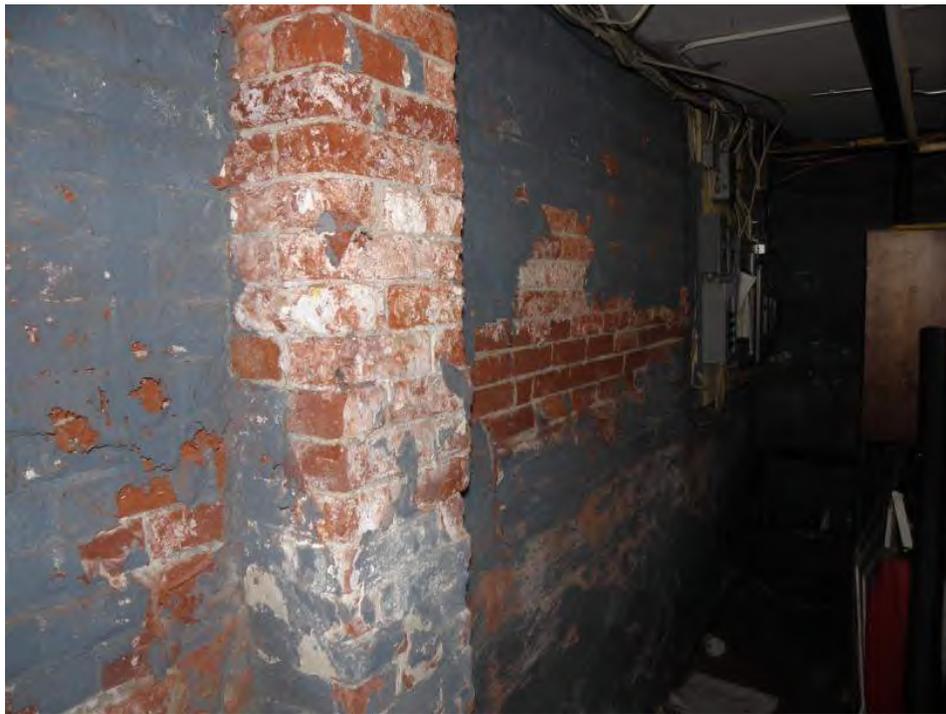
Photo 61

Interior surface of brick foundation. Bricks have spalled, but mortar is still solid.

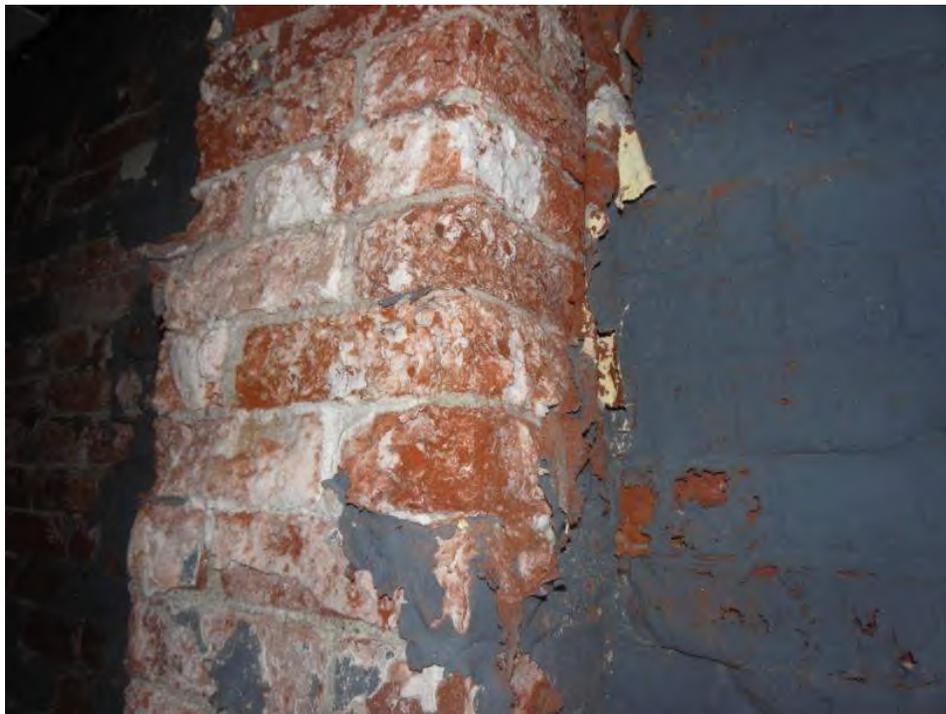
Photo 62

Closer view of spalled foundation brick shown in photo 61.

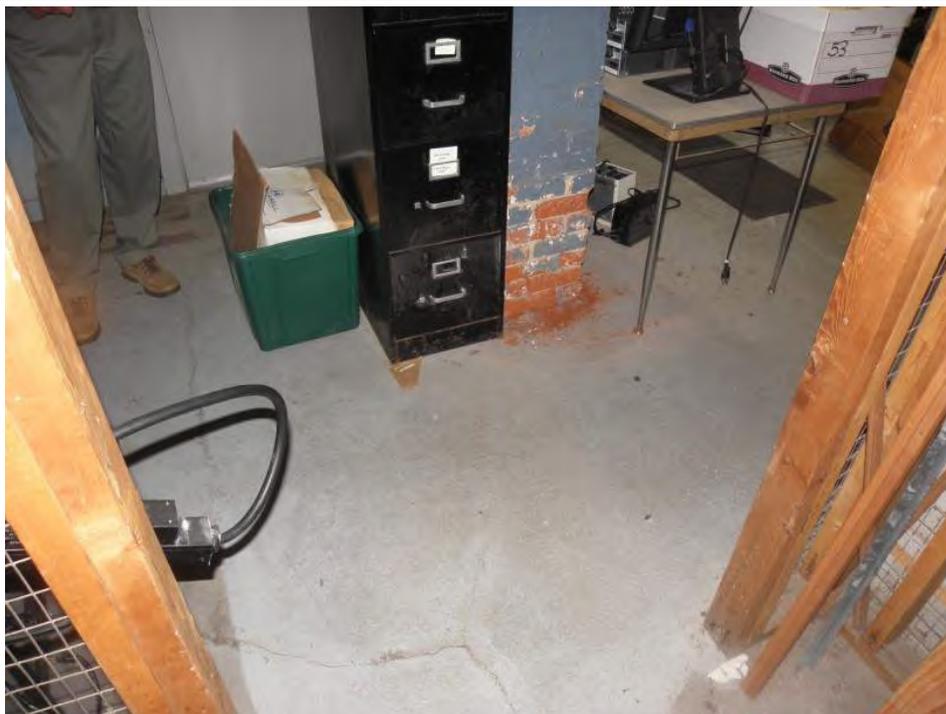
Photo 63

Deteriorated brick at base of basement pier.

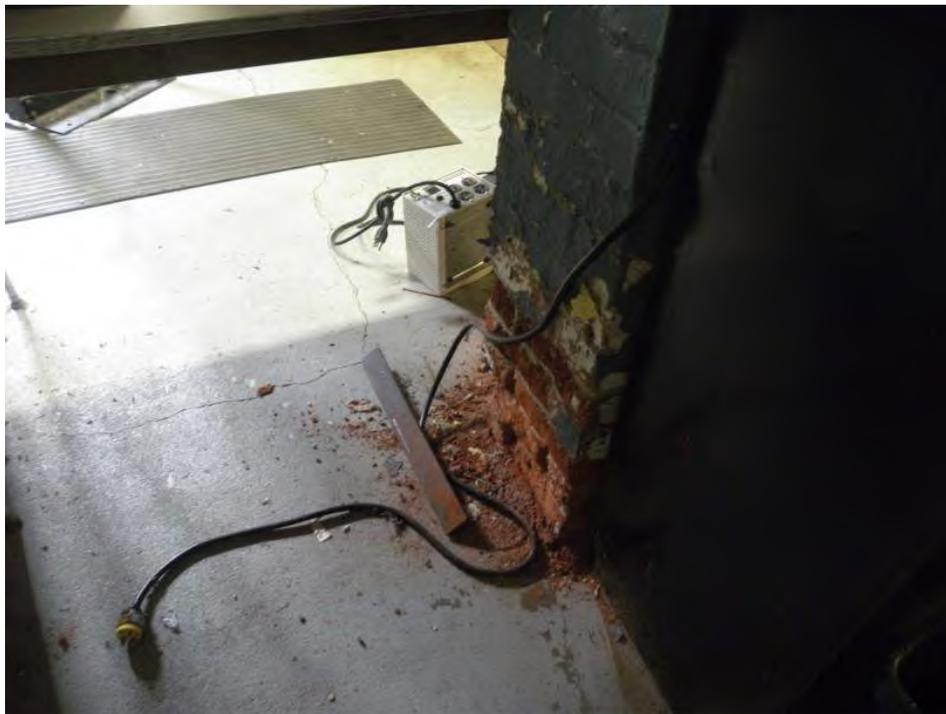
Photo 64

Deteriorated brick at
base of basement pier.

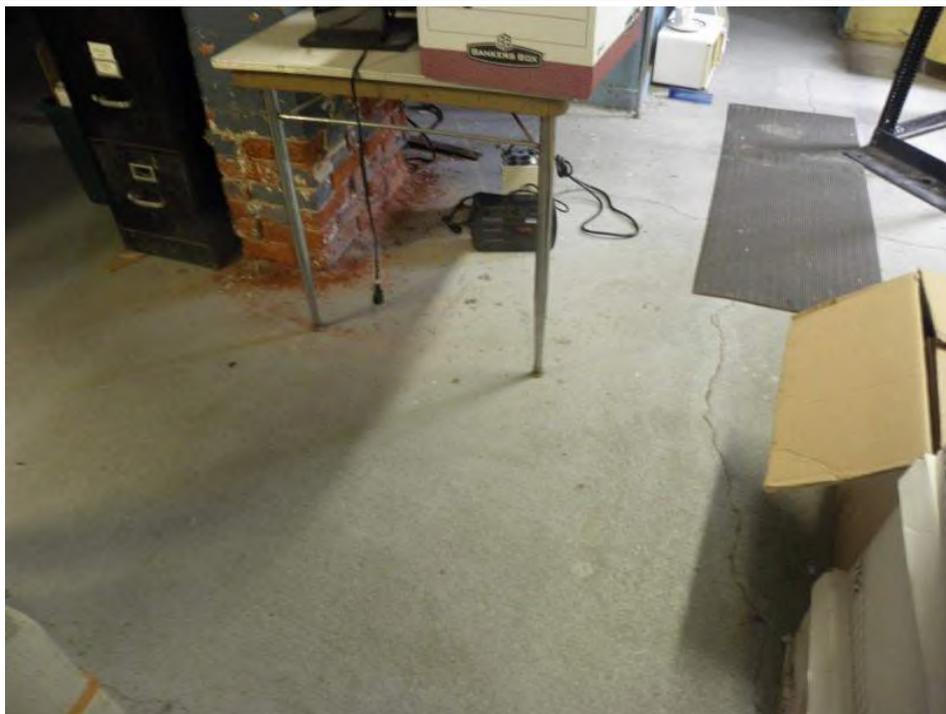
Photo 65

Deteriorated brick at
base of basement pier.

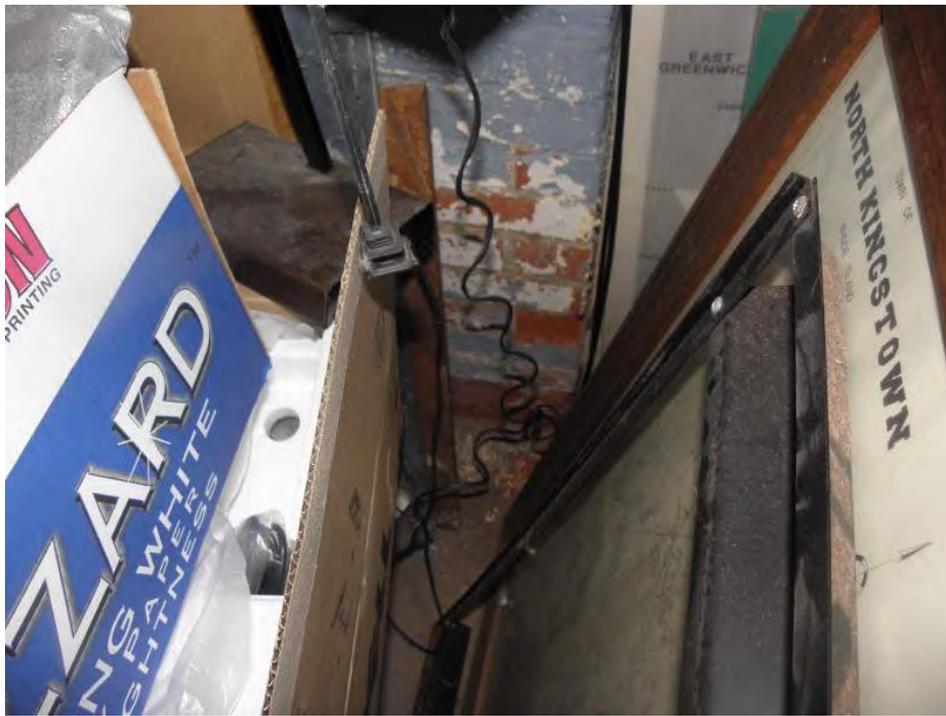
Photo 66

Deteriorated brick at the base of a second basement pier.

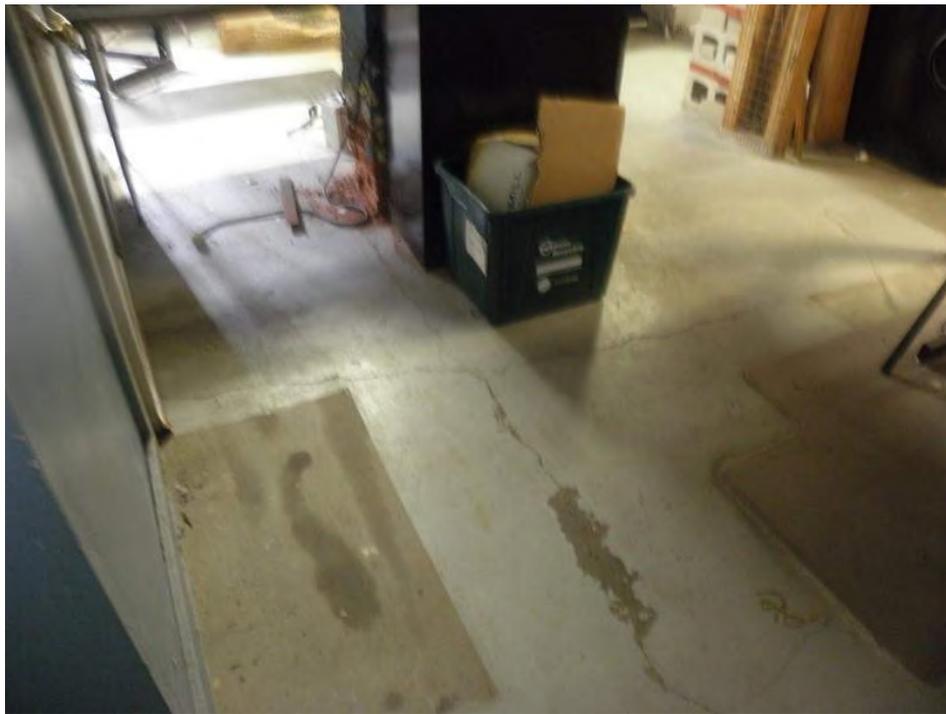
Photo 67

Random shrinkage cracks in the basement floor slab.

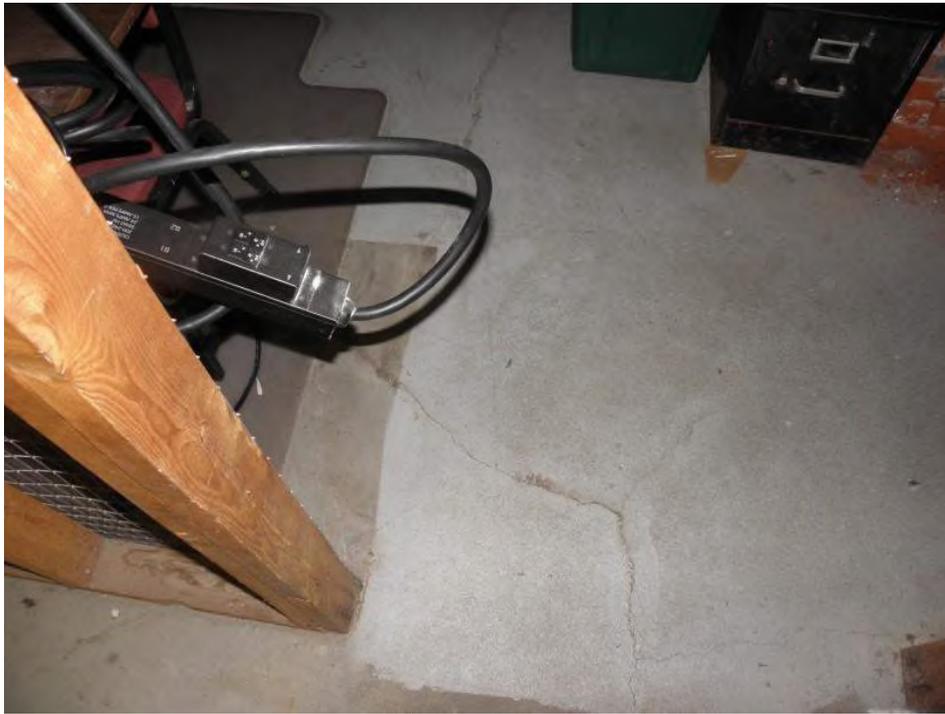
Photo 68

Random shrinkage cracks in the basement floor slab.

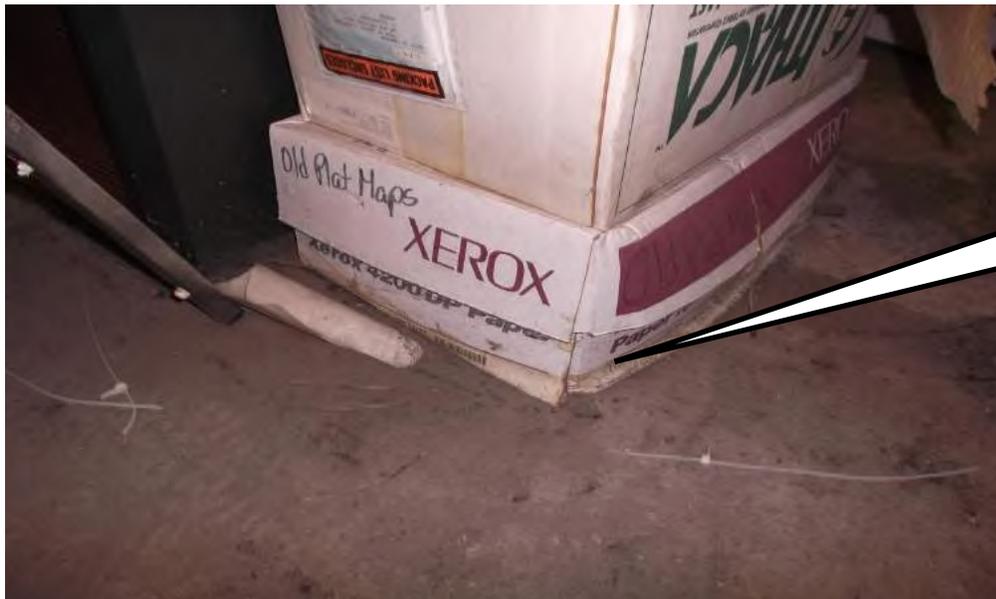
1. I expected to find relatively high levels of mold spores in the basement. There was a slight *moldy-musty* odor, paper products were stored directly on the concrete floor, there were obvious signs of water intrusion, a bathtub was partially filled with stagnant water and a wooden (false) floor had clearly been saturated with water (see photos below).

Water Stains and
appearance of
mold growth

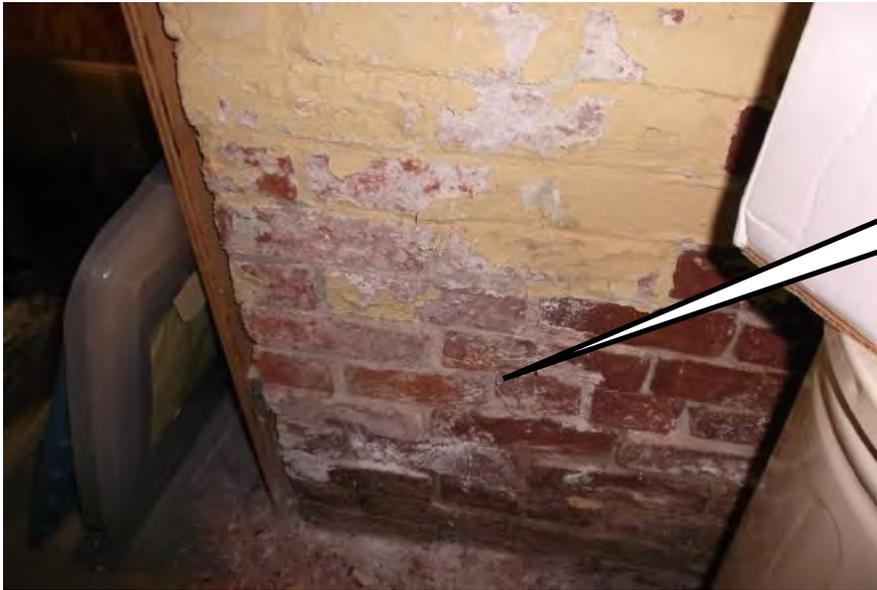
More water intrusion in the basement

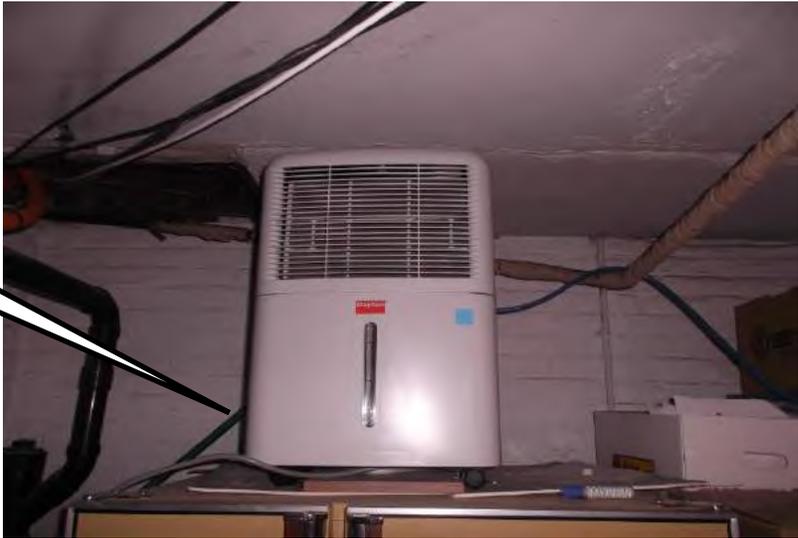
2. A dehumidifier had been placed in the basement to reduce the airborne moisture. It contained an over flow tube (into the bathtub) but the humidifier's reservoir was full of stagnant water.

Overflow tube to the TOP of the reservoir
