North Kingstown Town Hall & Annex

Building Improvements Feasibility Study 2016

Prepared By:
Aharonian & Associates, Inc.
310 George Washington Hwy
Smithfield, RI 02917

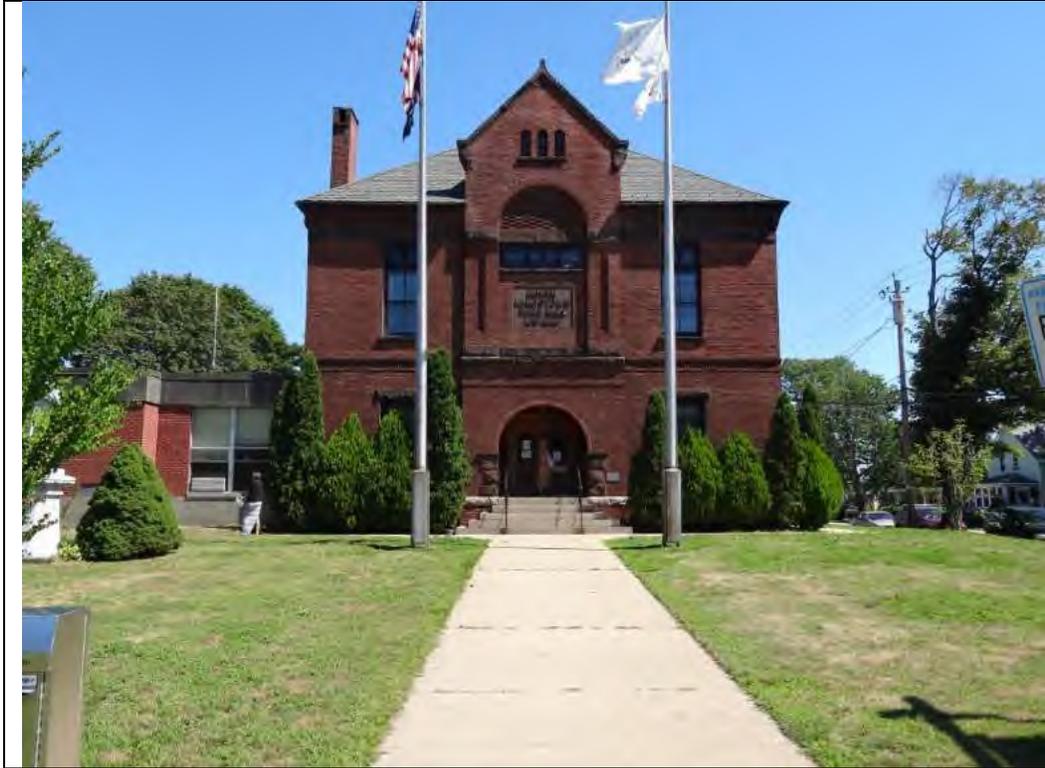
Photo 1

The exterior of the building is in good condition but needs minor repointing repair of the brickwork and a total cleaning and wash. It was that noted more extensive repairs to the two brick chimneys are needed. There are areas of repair needed to the brick at the gable roof edge and a crack that needs repair at the front of the building (south facing). Refer to photos 1,2,3 and 4.

1. Brick should be repointed and mortar replaced where missing. Brick should then be cleaned and restored.
2. Steel lintels at brick openings at additions should be at a minimum scraped and rust removed and repainted with rust prohibitive paint. Alternative would be to replace lintels with new galvanized lintels in kind.

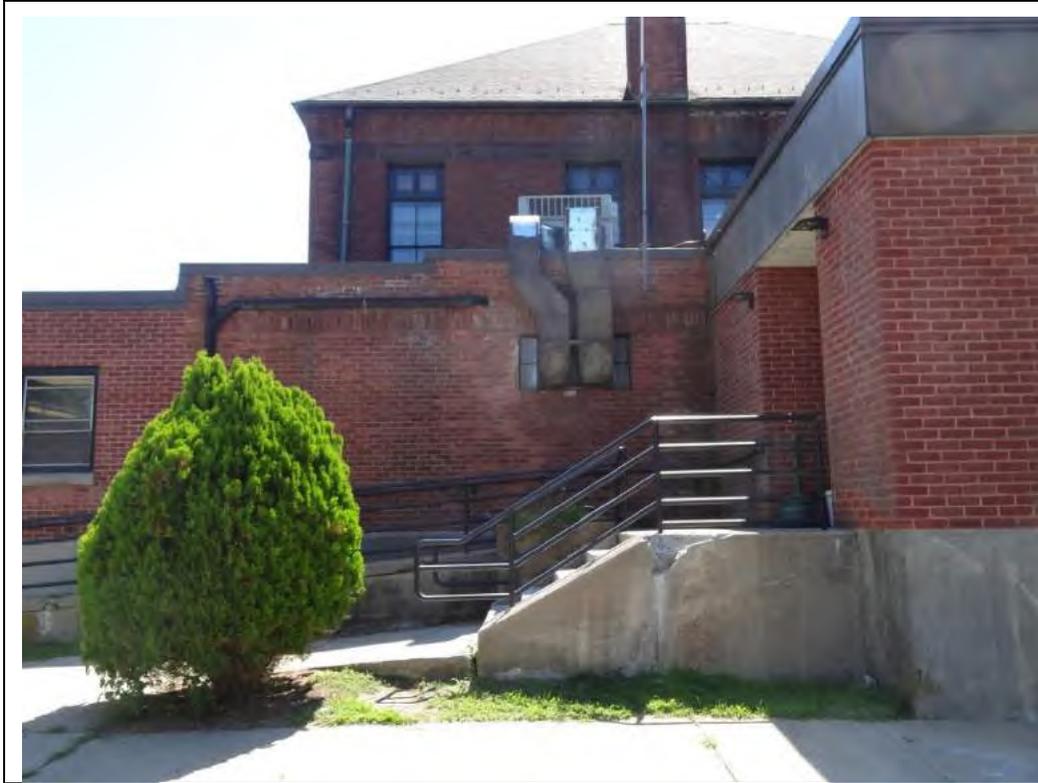
Photo 3

The basement foundation wall of the building shows signs of moisture and deterioration of the brick foundation. The structural report addresses this issue and will address the structural integrity of the foundation. The most damaged area is located at the basement stair east wall. The stair enclosure to the basement houses the main electrical distribution and panels. This location impedes the stair access and egress path. The electrical system should be in a separate room so that those who need access to the equipment may do so in a safe manner. It was noted that there are many penetrations for various pipes and ducts that are not sealed on the masonry walls in the basement. Refer to photos 3, 5, 6, and 16.

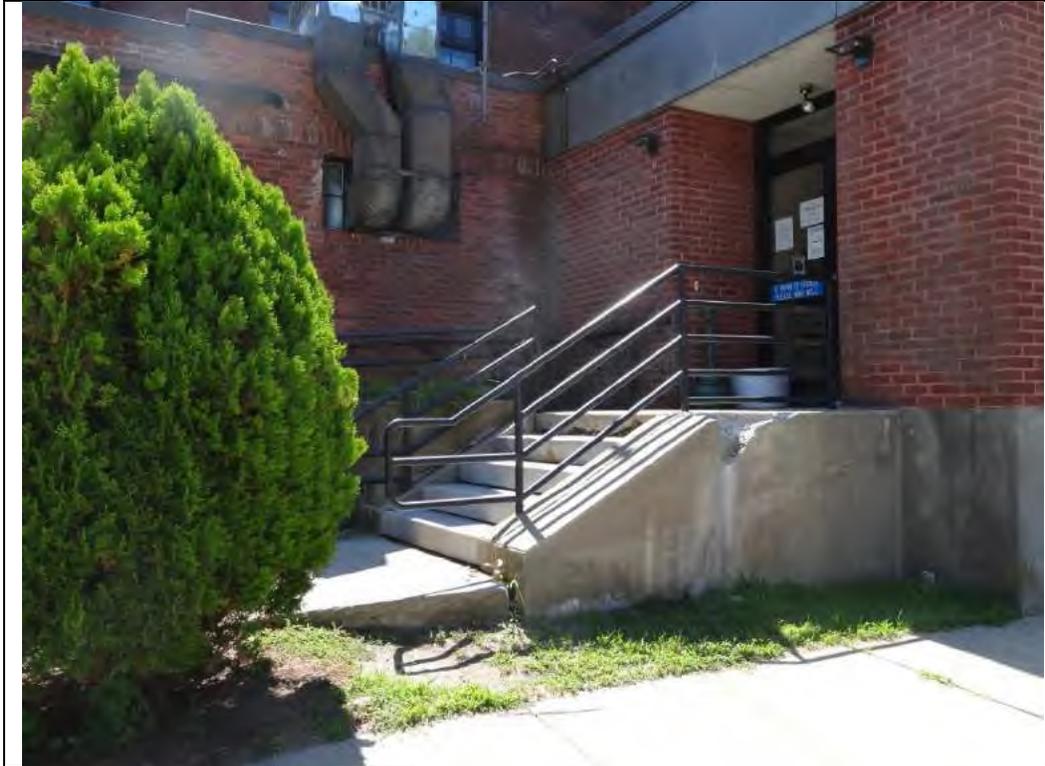
Photo 5

In the east entry to the building, the granite stairs are showing signs of settlement. There are no signs of cracking or breaking of the granite slabs. It was noted that a drain comes down at the corner of that stair entry and could be a reason that water draining is contributing to the settlement. The drains around the perimeter of the building should be further investigated and / or repiped into a drywell strategically located away from the building . The south stair and ramp is in need of repair at the landings and ramp. The guard and handrail at this entrance need to be brought up to code. This is also discussed in the structural portion of this report. Refer to photos 5 and 6.

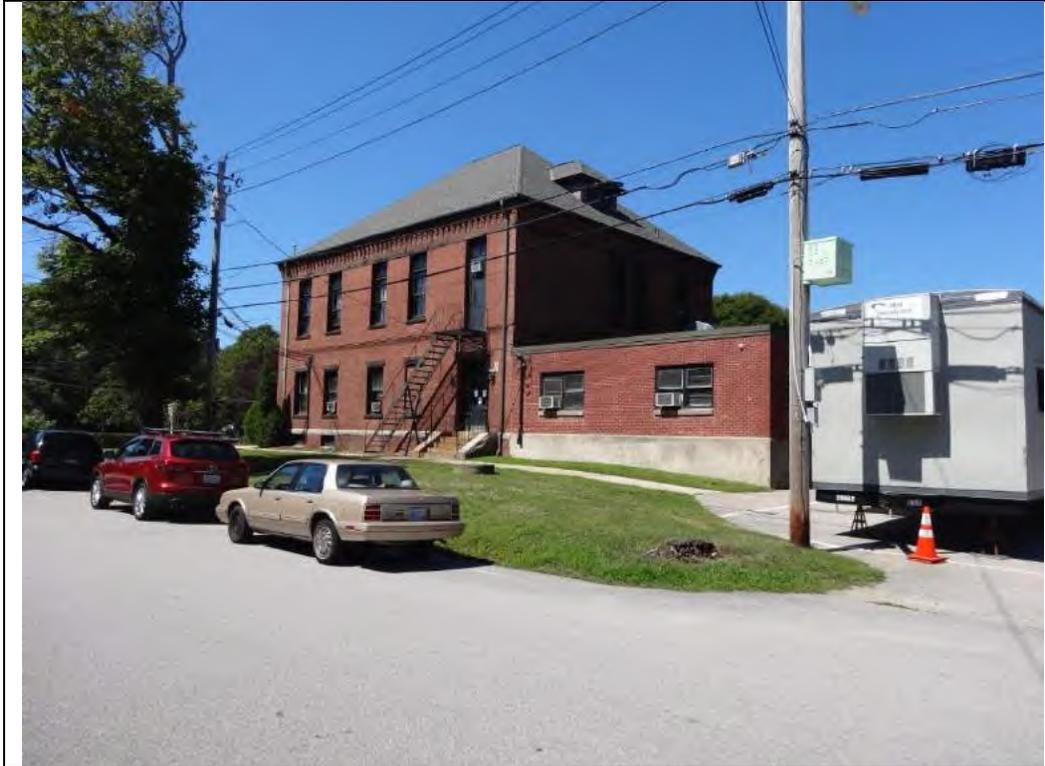
Photo 7

The exterior fire escape was noted to be in good condition with minor areas showing surface rust. Refer to photo 7.

3. Steel fire escape should be cleaned of rust and repainted if it remains in service or must be removed and door restored to window opening. (Code requirement is to install interior egress stair with consideration of remoteness.) (See Architectura report Appendix B)

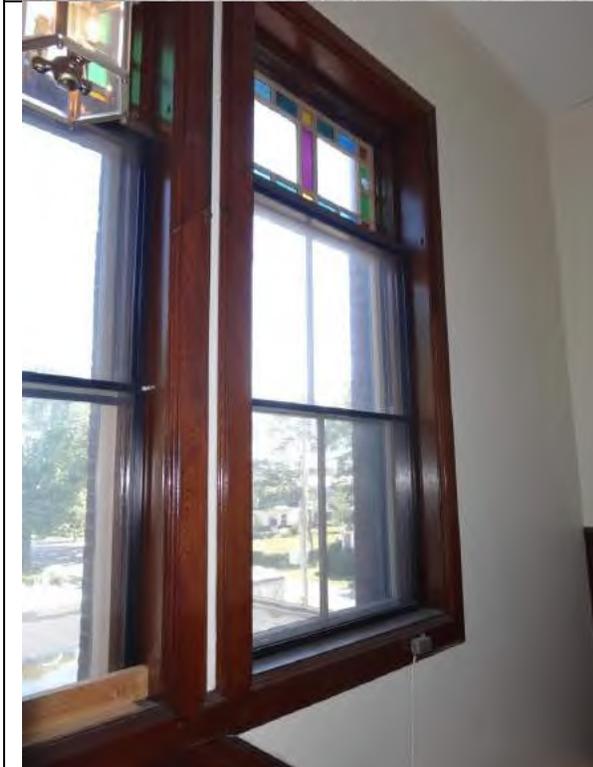
Photo 8

The windows are in good condition and all have aluminum storm windows mounted to the interior of the sash. It was noted that the building has gone through lead abatement. The roofs appear to be in good condition as well and it was noted that the pitched roof shingles were replaced in 1998 and the flat roof membrane in 2007. There did not appear to be any leaking in any of the roofs. This includes areas where the roof changes and around the flashing. Refer to photos 8 and 9.

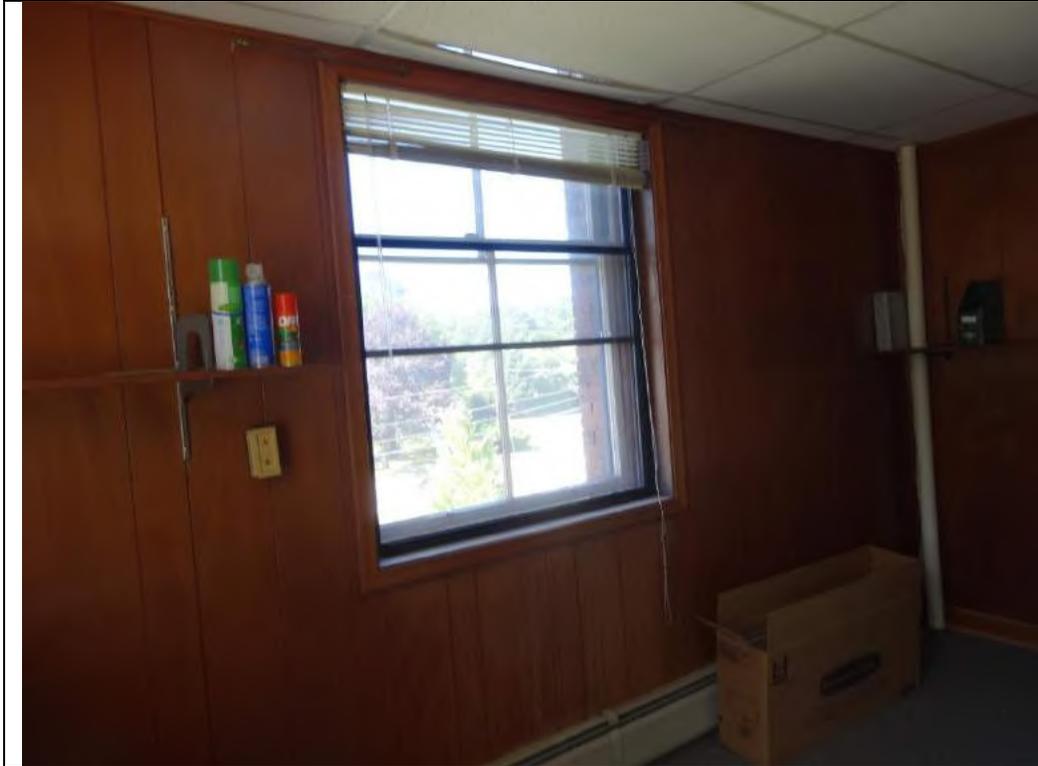
Photo 9

The interiors of this location are in very good condition and do not show any signs of cracking, major settlement or water damage. There is paneling on the walls of most of the offices on the second floor, which will need to be addressed. Refer to photos 9, 10, 11, 12, 13, 14 and 15.

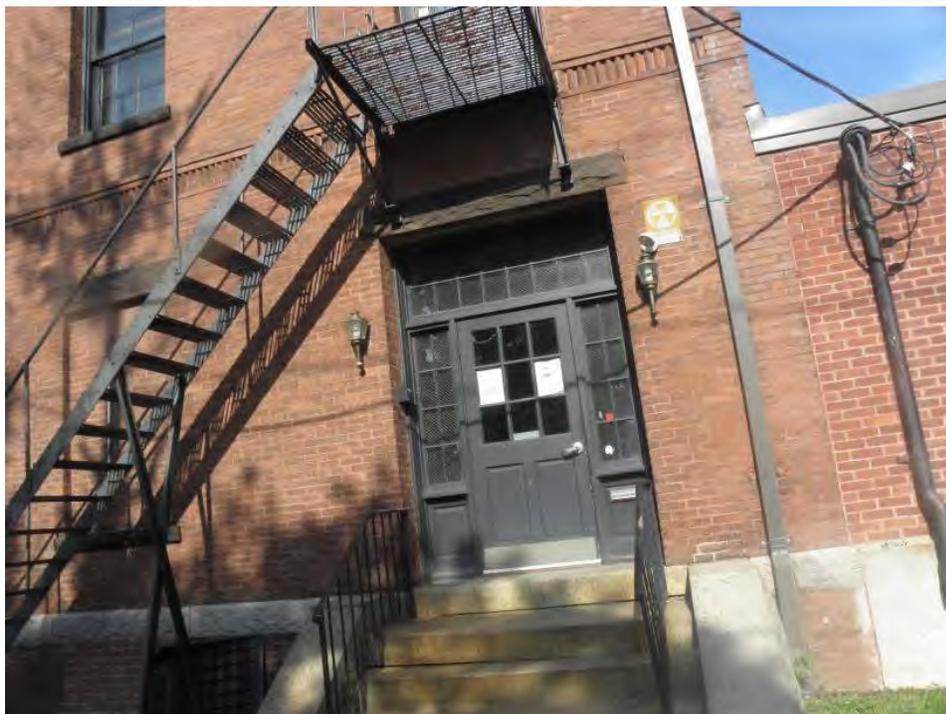
Photo 13

The exterior of the original building is in fairly good condition, considering its age. There are areas where repointing of the brick is required. Mortar was missing from the joints of the granite stairs at the front and east side of the building. The granite stairs on the east side have settled slightly toward the rear of the buildings. There is a downspout from the roof that enters the ground adjacent to the settled side of the stairs refer to photos 17 to 20.

East side granite stairs and steel fire escape.

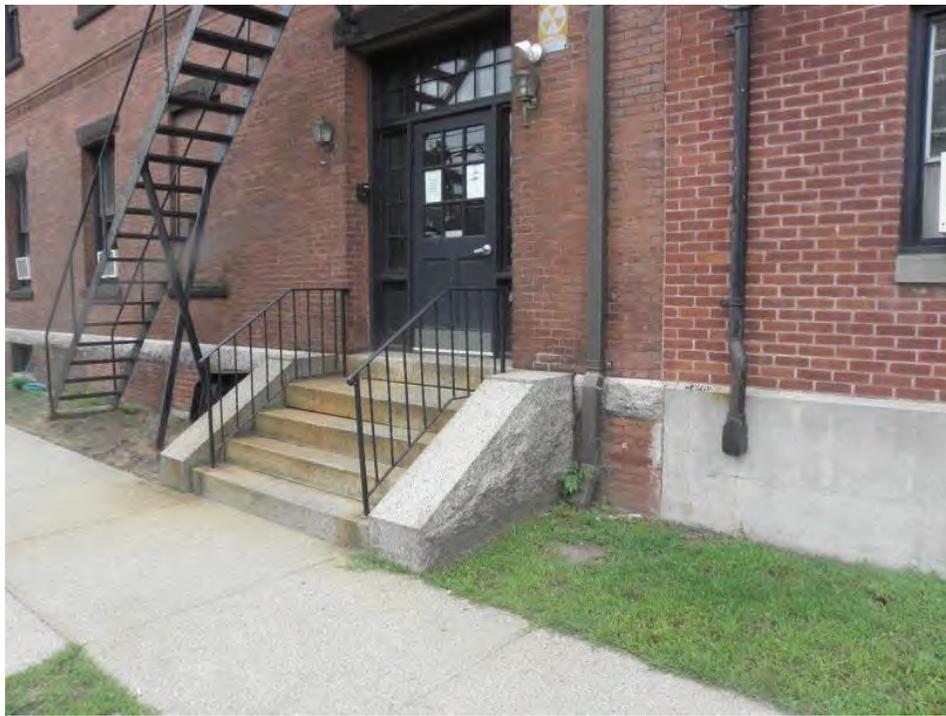
Photo 14

East side granite stairs
and steel fire escape.

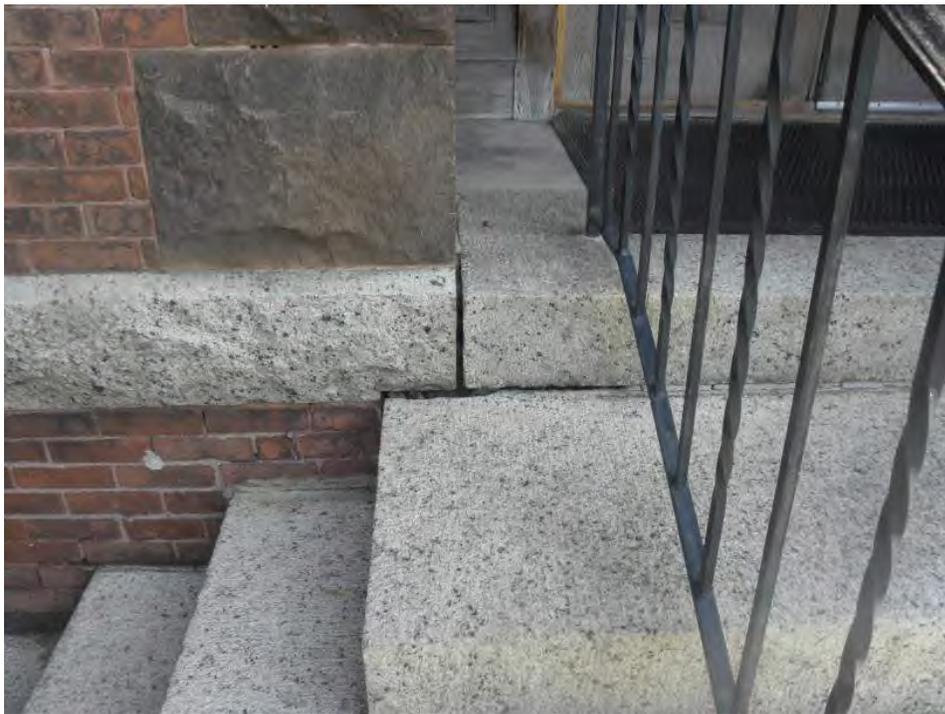
Photo 17

Mortar missing from the joints at the front exterior granite stairs.

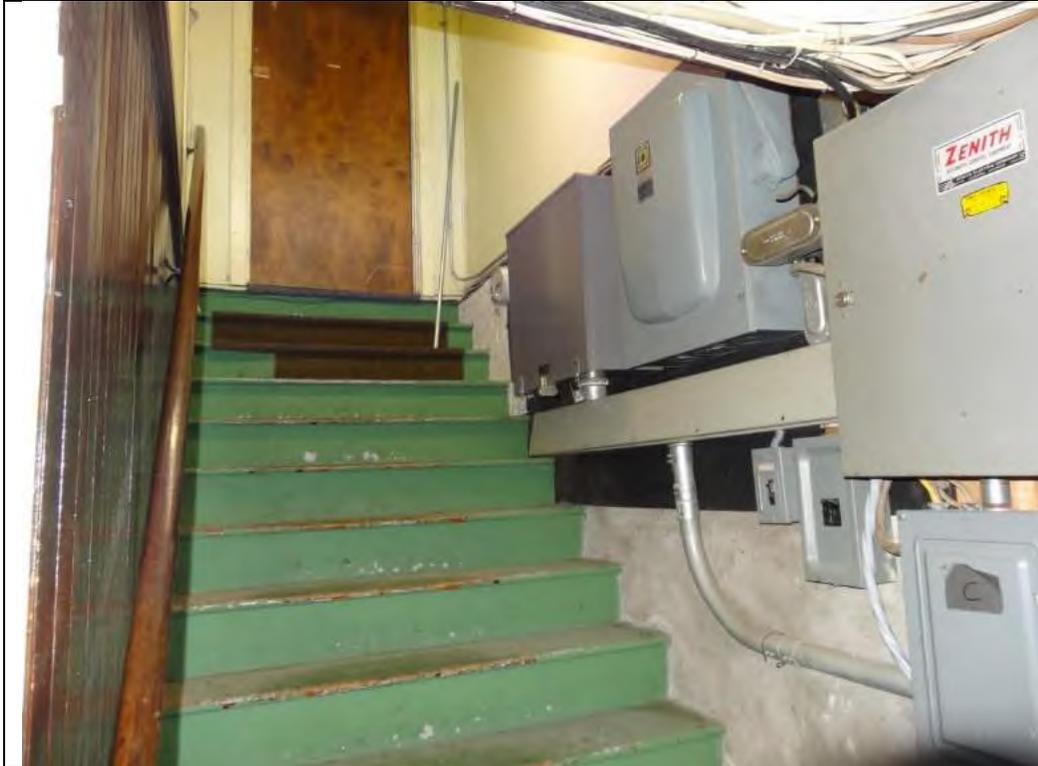
Photo 15

Upon review of the existing service, it was noted that it has been installed in a non code compliant. Refer to photo 15. It was also noted that the main distribution panel is mounted to the existing brick wall that needs repair (refer to photo 16) and is supported by two 4 x 4 wood posts under the box. The remaining distribution circuit breaker panels and electric main service run up the wall of the only "means of egress" stairwell from the basement.

1. Install new outside riser with a 400 amp meter socket that would enter the basement and install a new main distribution panel (MDP). The new MDP would be installed in the adjacent room to the existing location, identified as the vault.
2. The new MDP panel located in the vault will support all the circuits that are not powered with generator backup.
3. Relocate electrical transfer switch to the adjacent vault with an additional new 200 amp panel fed through that switch which would feed all the circuits that are backed up by the emergency power.
4. Transfer all the circuits to the new panels, then remove the existing panels and service from the stairwell.
5. It should be noted that if the breaker panels are upgraded, the wiring may need to be upgraded to be code compliant as well. Refer to photos 17, 18 and 19.
6. All junction boxes and exposed wiring should be in boxes and covered.

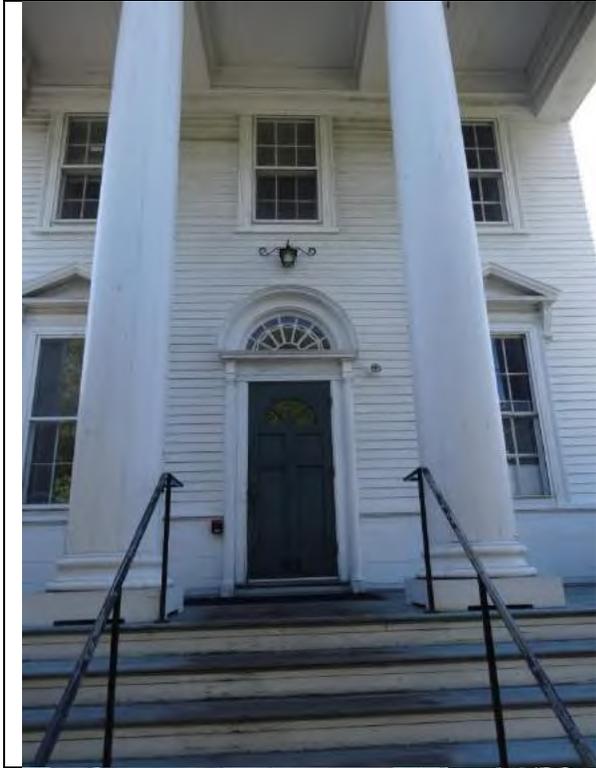
Photo 1

The exterior of the building is in good condition but needs trim repair and painting. The windows, which are also in good condition, all have aluminum storm windows mounted to the exterior. It was noted that the building has gone through lead abatement when it was previously painted in 1998. The roofs appear to be in good condition as well and it was noted that the pitched roof shingles were replaced in 1998 and the flat roof membrane in 2007. There did not appear to be any leaking in any of the roofs or in areas where the roof changes and has flashing. Refer to photo 1.

Minor repairs to the siding need to be provided before repainting. Cornice trim at the gable ends and dentils that are decayed and damaged need to be repaired, replaced and all repainted. The Brown Street columns at the entry need to be repaired and repainted. At the entry location, the entry stairs and base wood trim is decaying and needs to be replaced, repaired and repainted. Refer to photos 1, 2, 3 and 4.

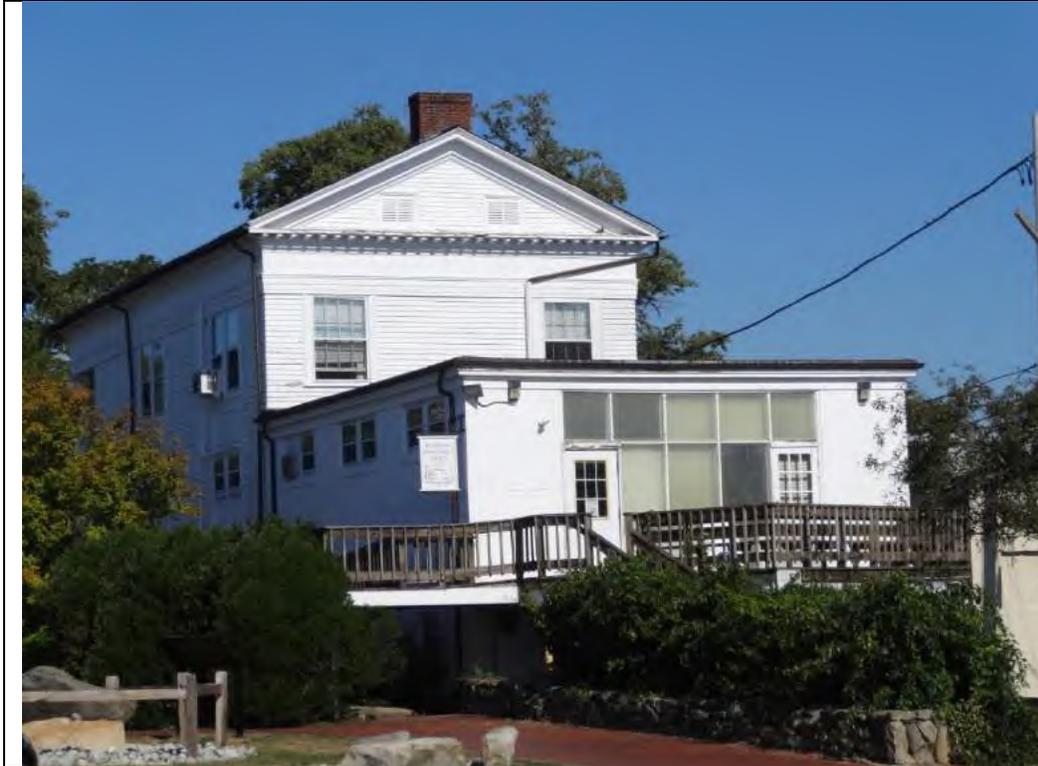
Photo 5

The rear deck and entry stairs from the Municipal parking lot need to be removed and replaced due to age and decay. The structural support steel columns and beams supporting this deck show major rust which is compromising the integrity and strength of the deck. There are areas that show rust penetrating through the beams' top flanges. Refer to photos 5, 6, 7, 8, 9, 10 and 11.

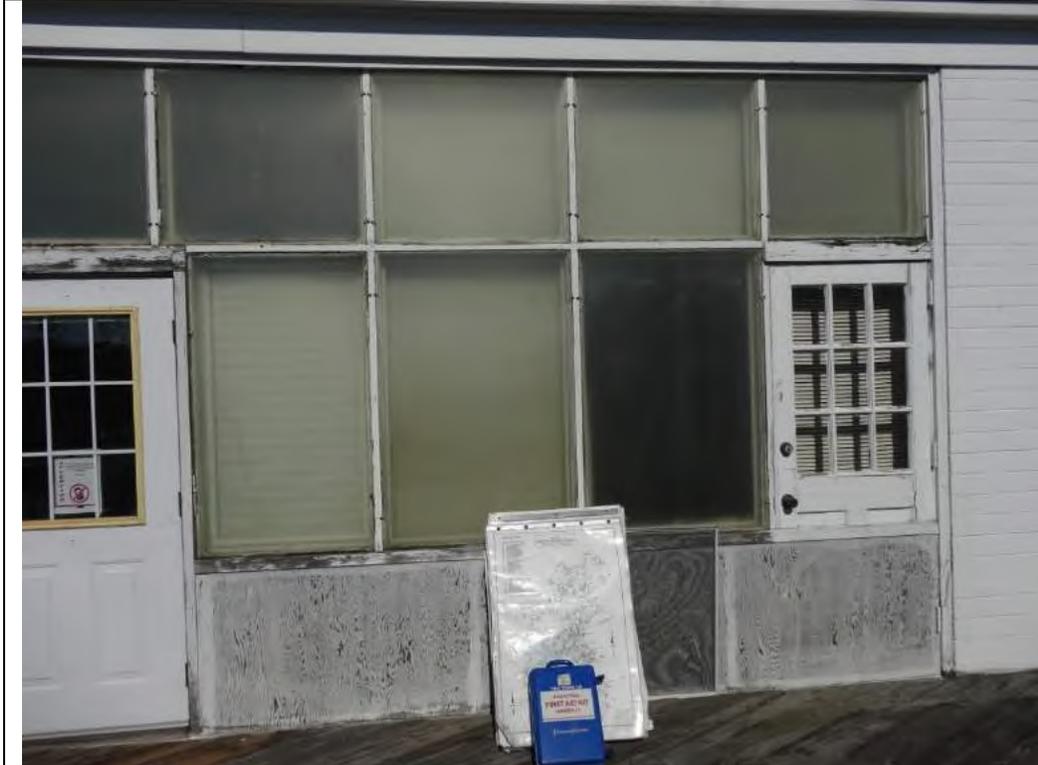
Photo 12

The rear entry to the building from the deck includes two entry doors and a large wood framed window wall that is in total disrepair. It was observed that the window framework is decaying due to the weather and the windows have lost their seal and are discoloring, which indicates there is no insulating value to the glass. Refer to photo 12.

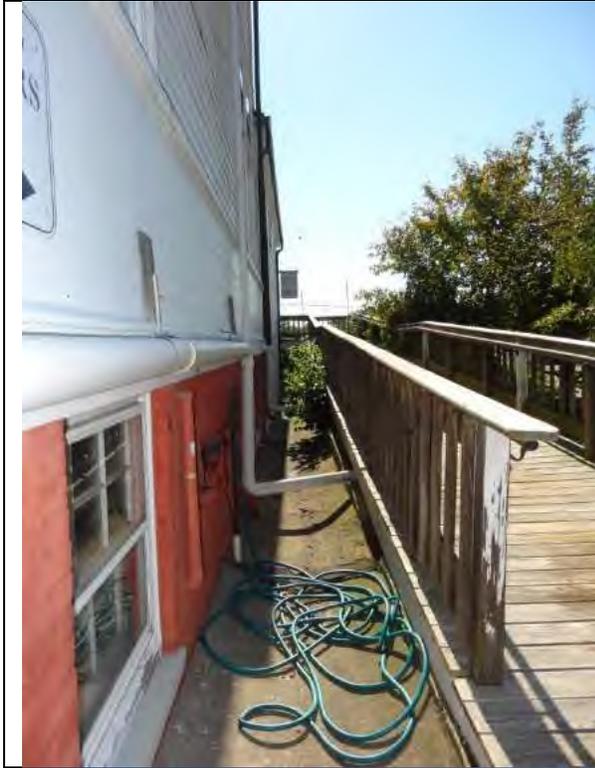
Photo 13

The roof drains are routed to the north east and south east portions of the building and are typically spilling out onto the municipal parking lot. The surface drainage sheet flows to the catch basin and drywell located at the center of the parking lot. Refer to photo 13 and 14.

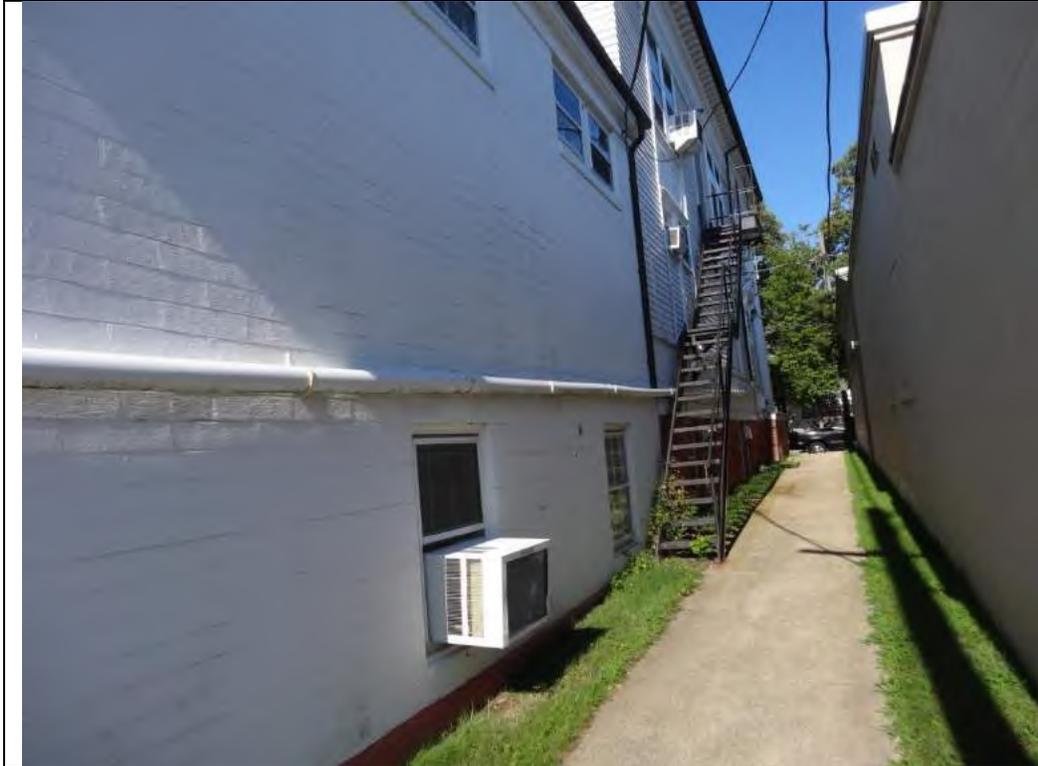
Photo 15

The steel fire escape on the north side of the building is in need of removing the rusted area and refinishing. In general, the stair is in fair condition. The Exit egress door to this stair from the second floor is difficult to open. Refer to photo 15.

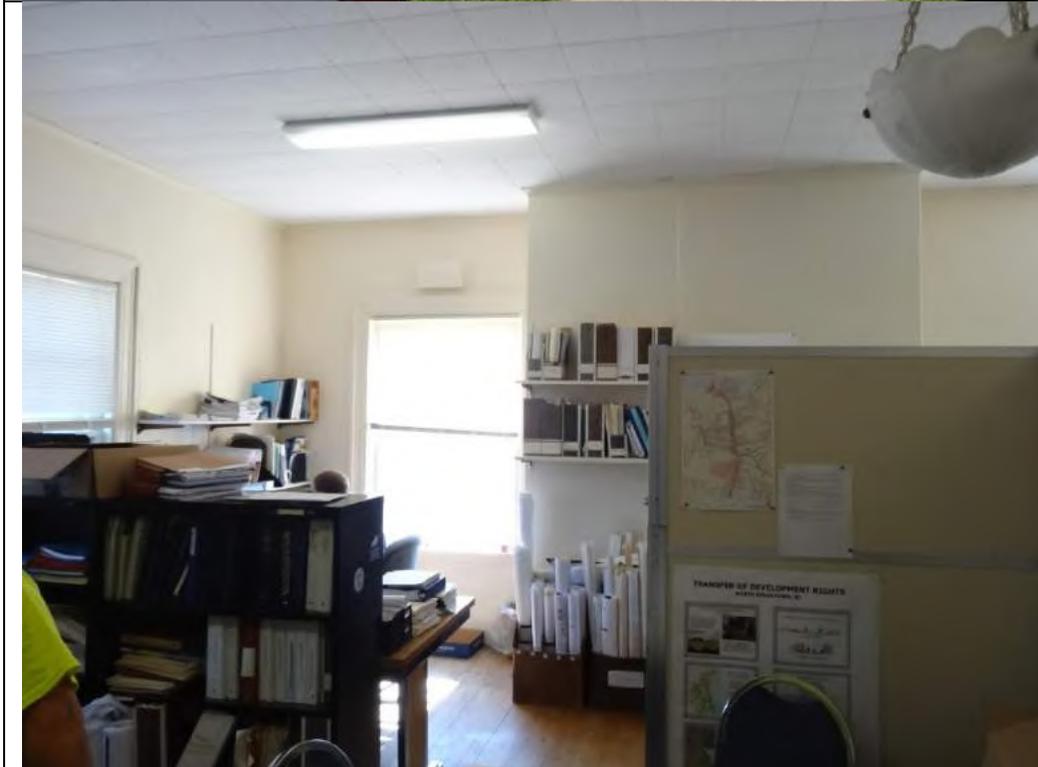
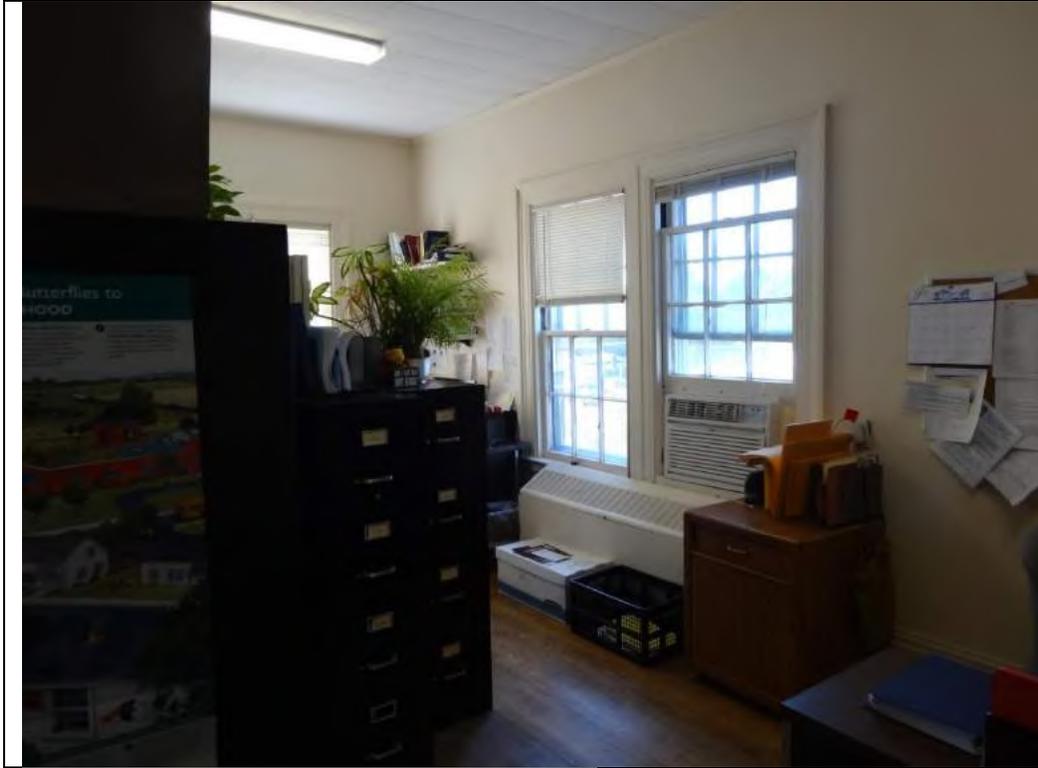
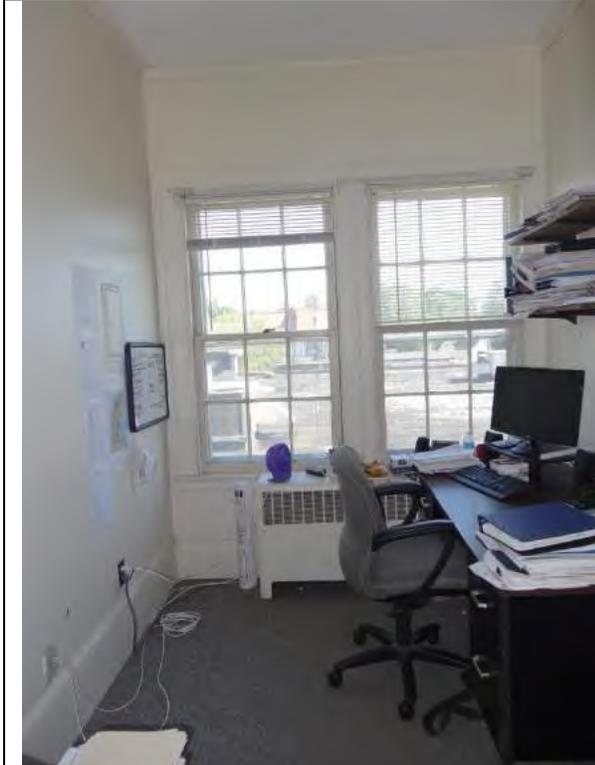
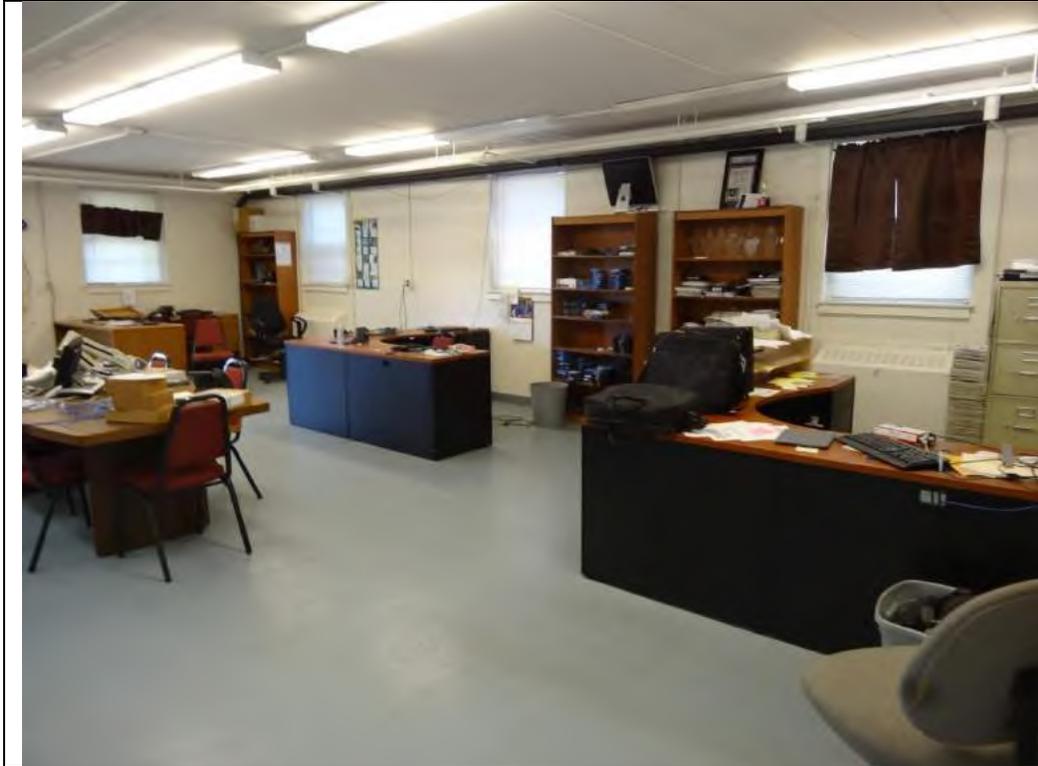
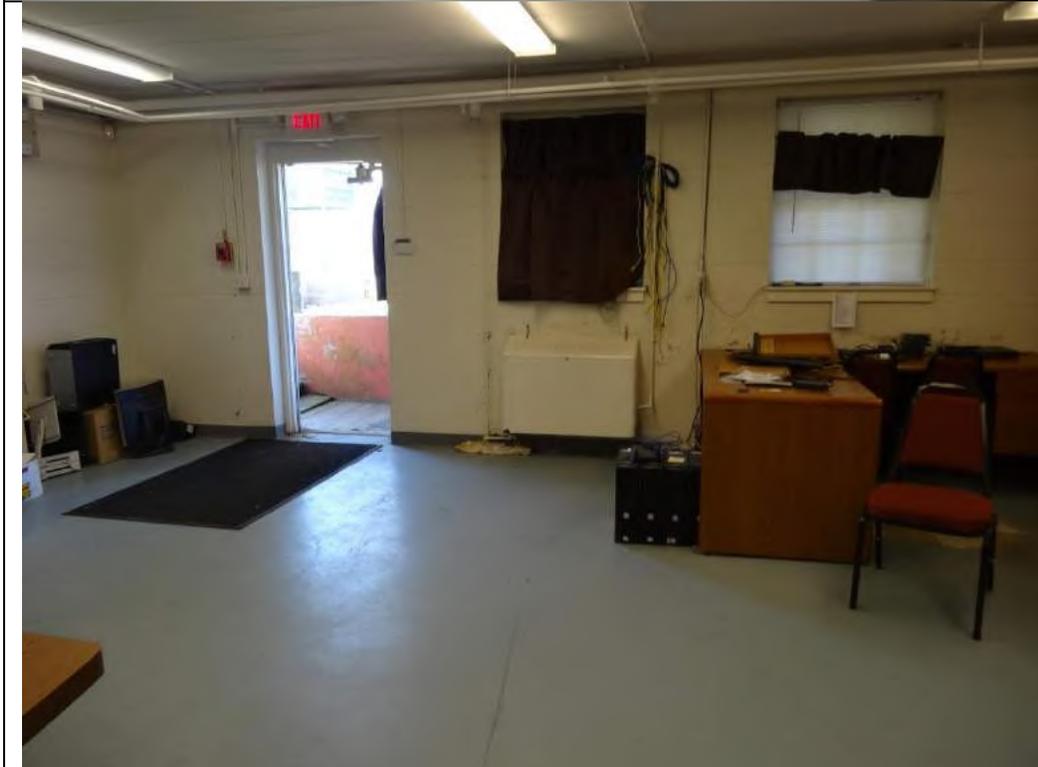
The interiors of this location are in very good condition and do not show any signs of cracking, major settlement or water damage. Refer to photos 16, 17, 18, 19 and 20.

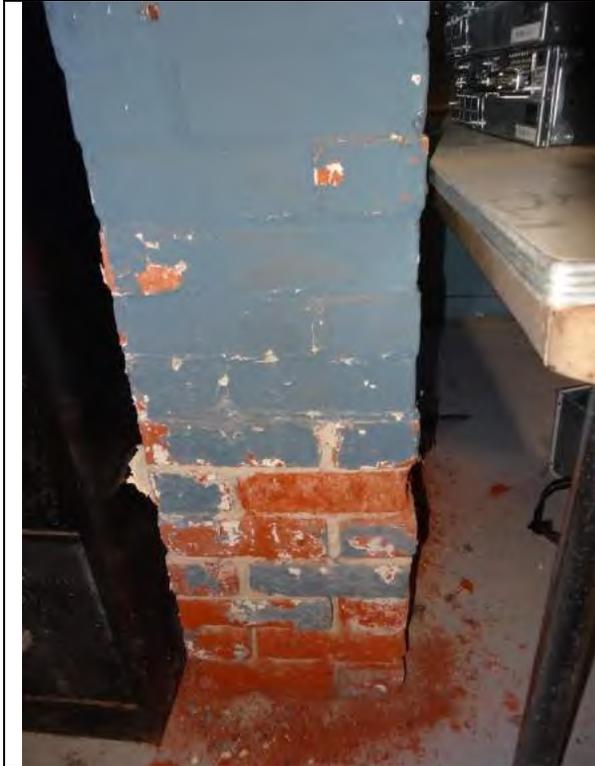
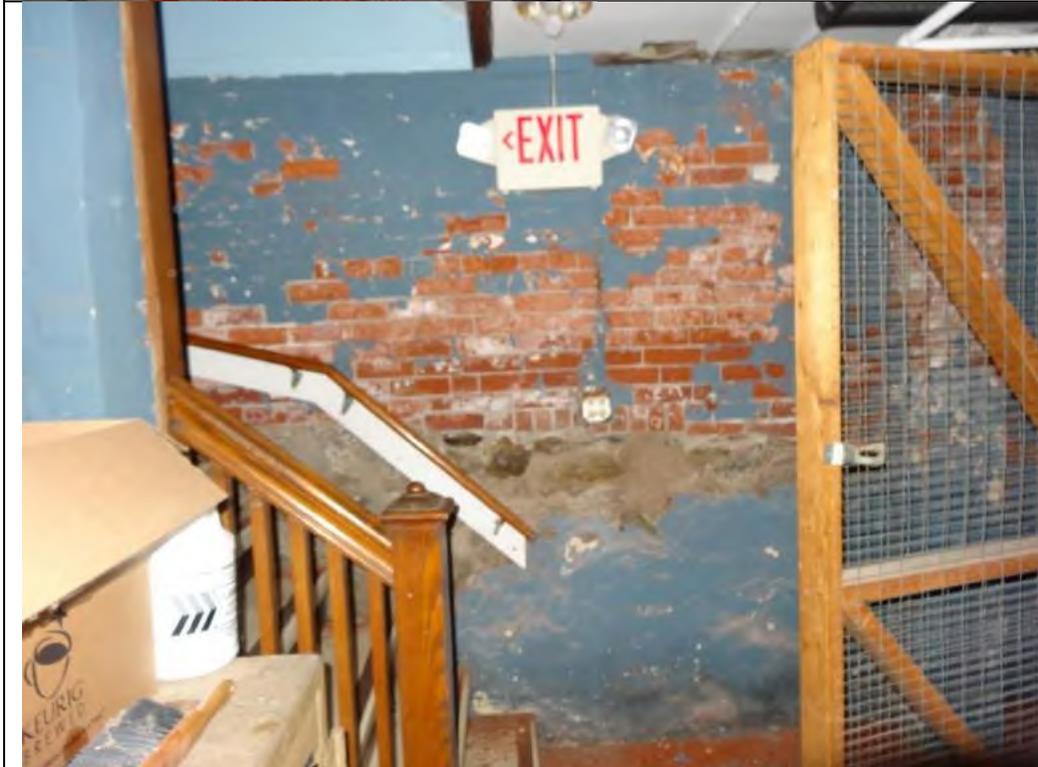
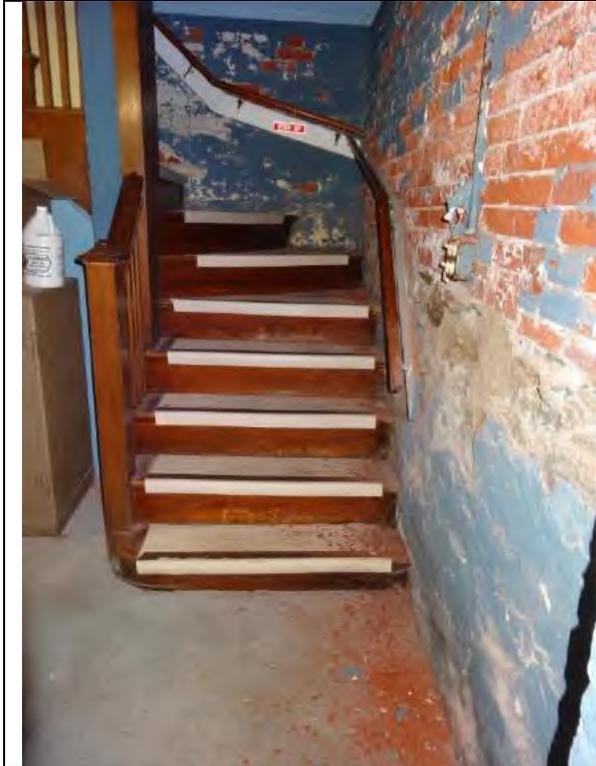
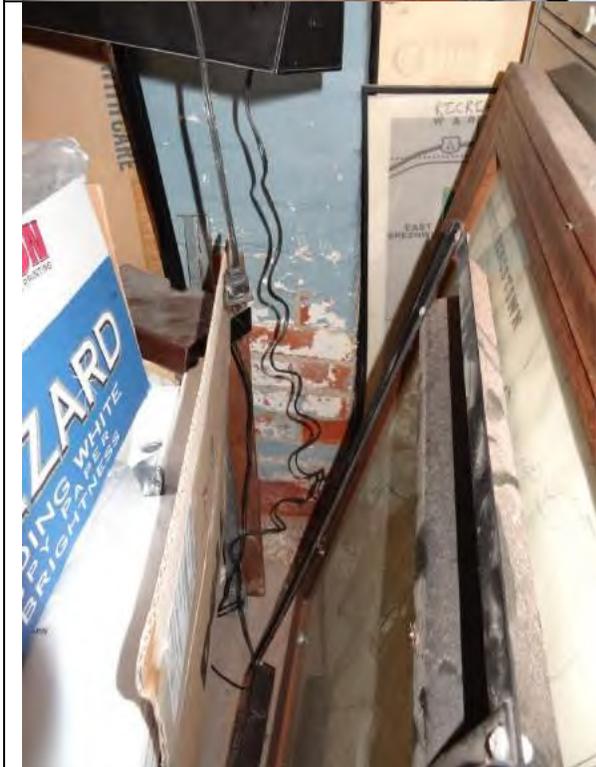
The basement in the west portion of the building (original building) shows signs of moisture and deterioration of the brick foundation. The structural report addresses this issue. The enclosure around the furnace room needs repair and the two toilet rooms are not operating and not usable. It was noted that there are many penetrations for various pipes, ducts and that they are not sealed. Refer to photos 21, 22, 23 and 24.

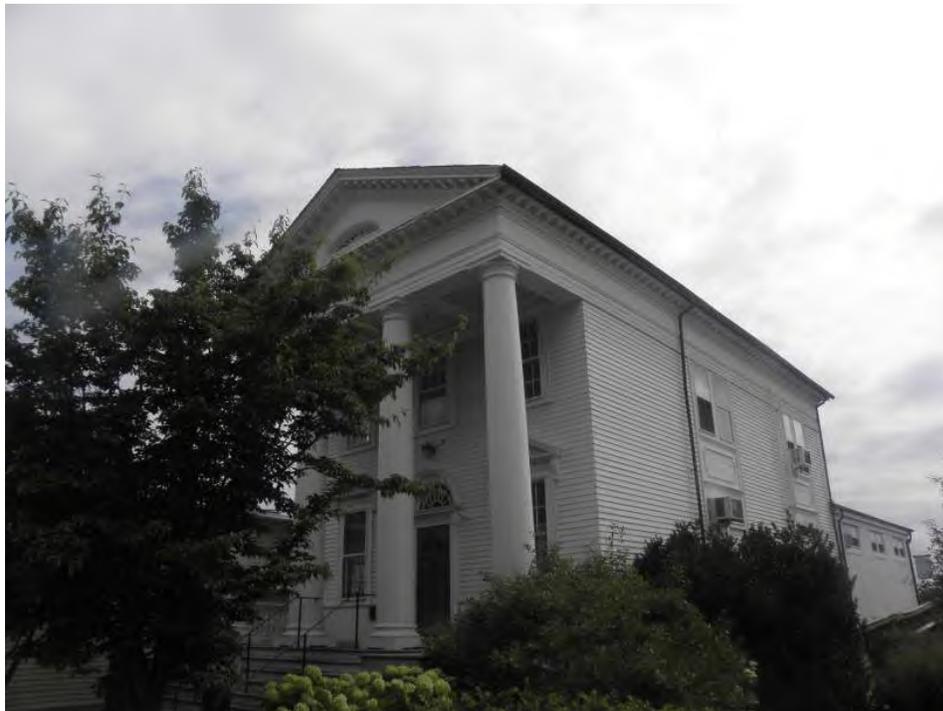
Photo 41

Front (west side) and south side of the building. Original building is two stories. There is a one-story addition at the rear.

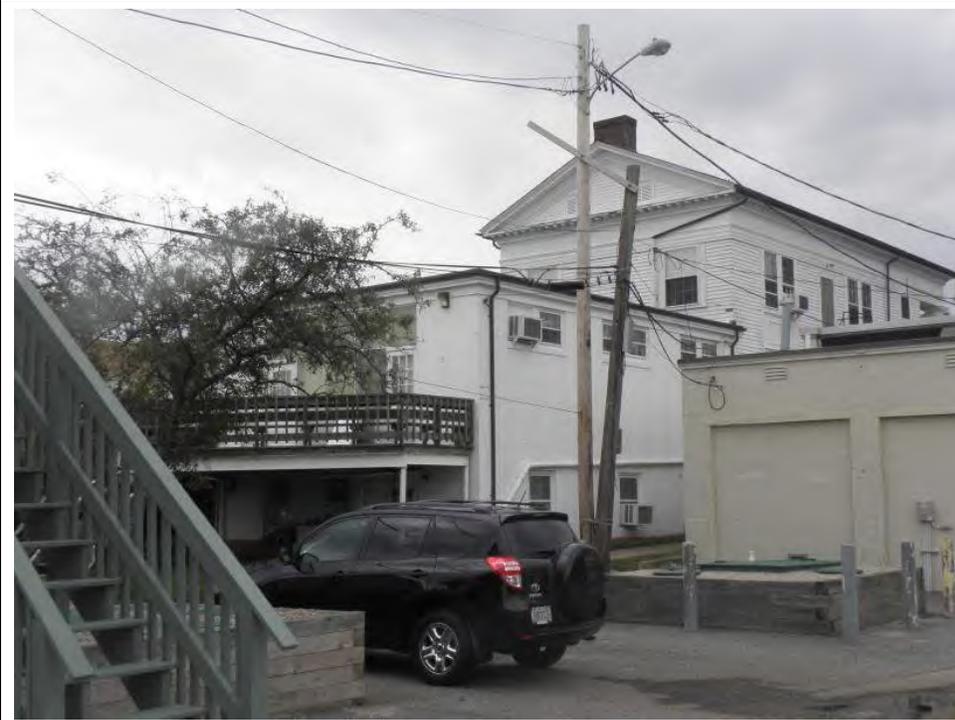
Photo 42

Rear (east side) and north side of the building. One-story addition with a basement at the rear.

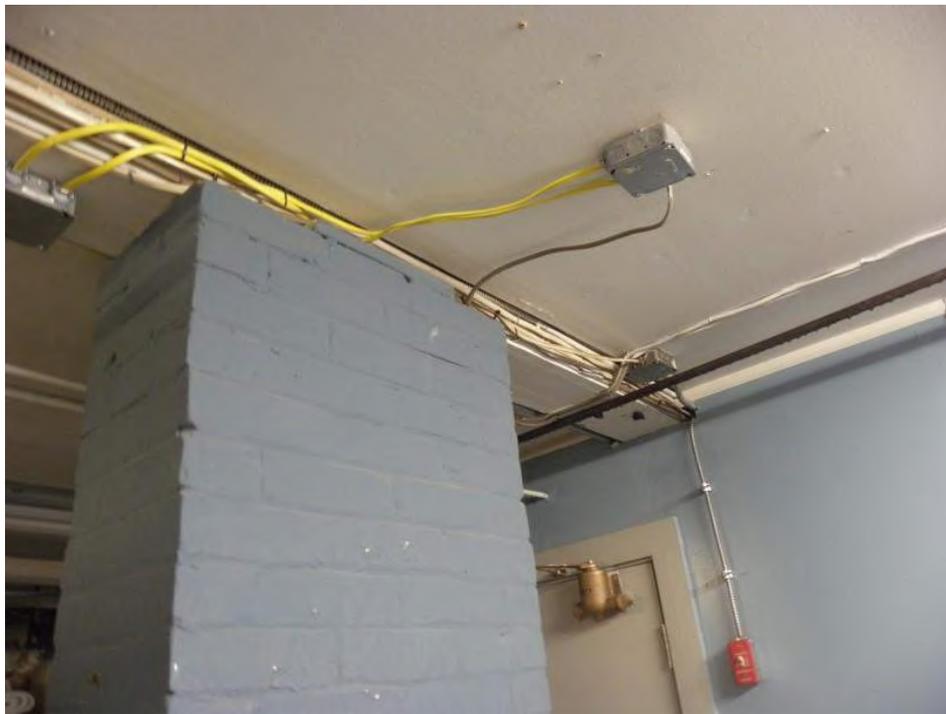
Photo 44

Brick pier supporting a beam below the center bearing wall in the base-mment of the original section of the building.

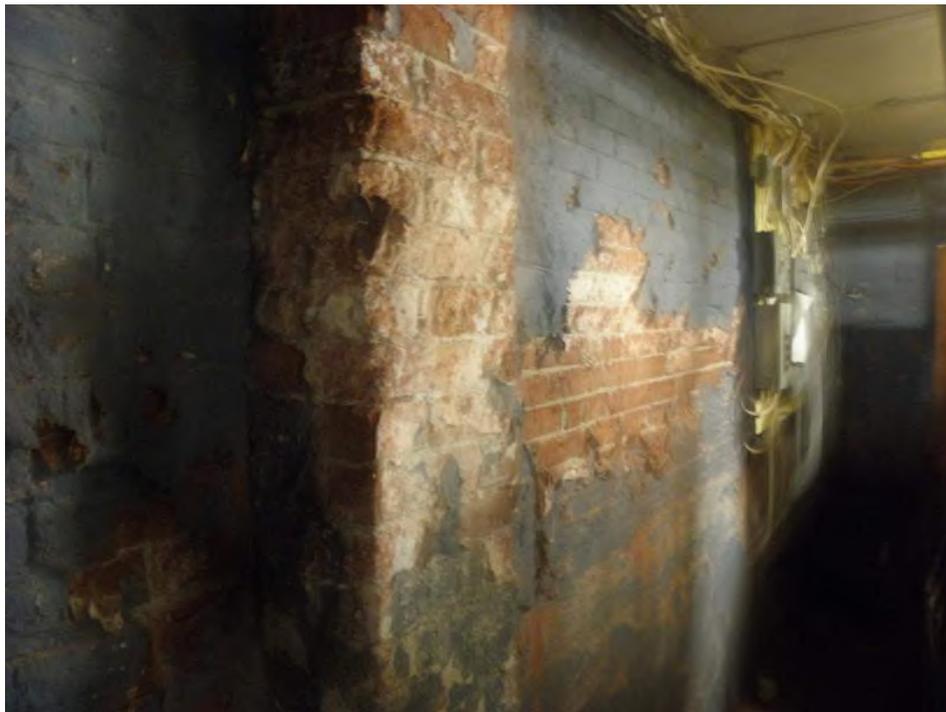
Photo 45

Foundation wall constructed with solid brick above mortared stone.

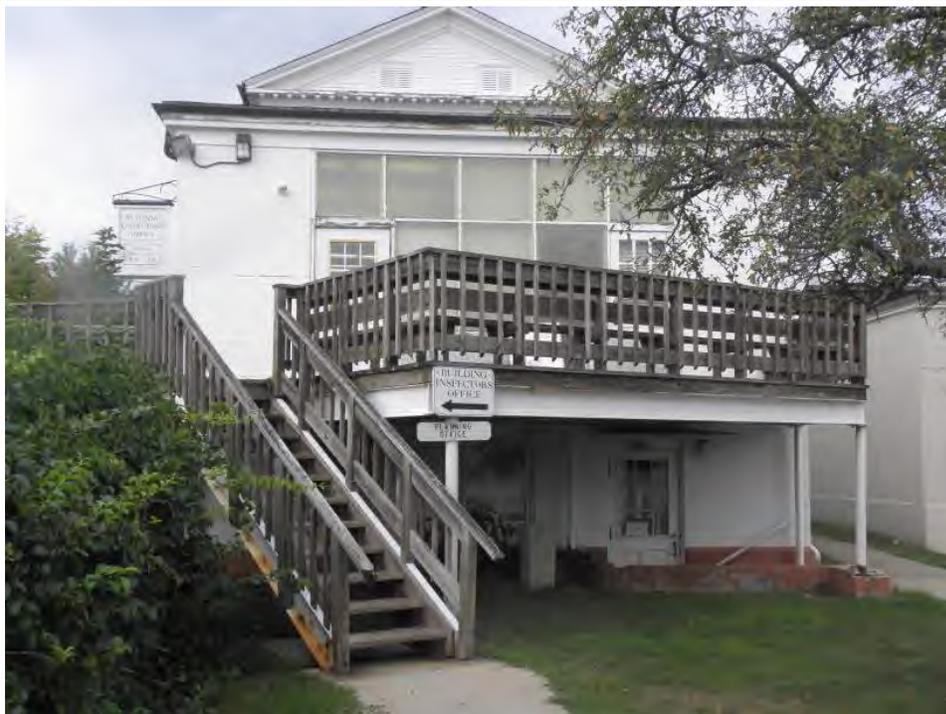
Photo 47

Rear wood deck on steel columns and beams.

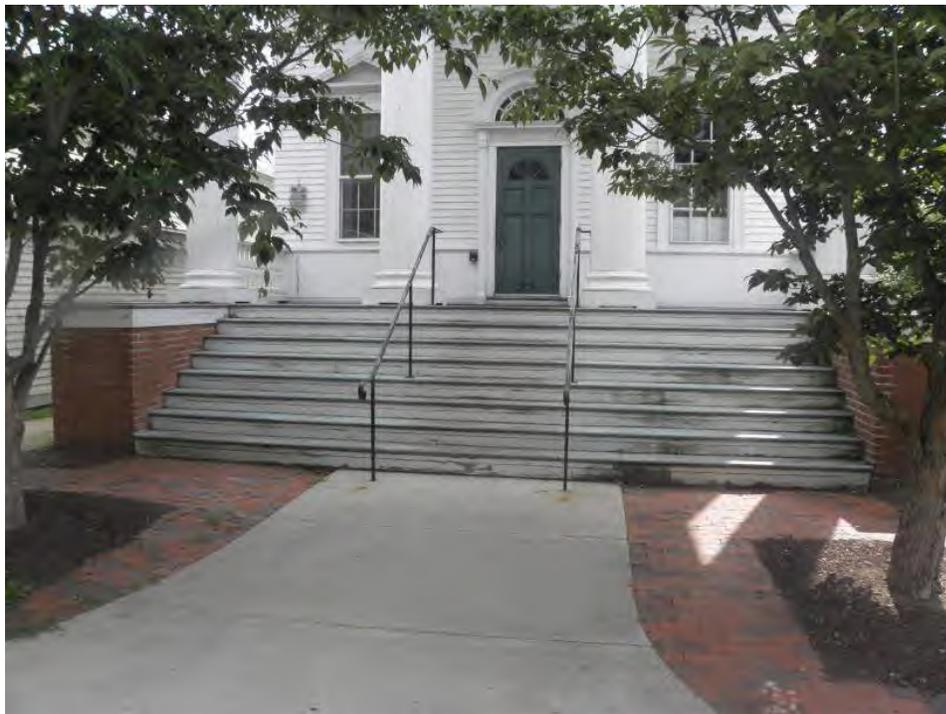
Photo 48

There is a front wood-framed porch with exterior wood stairs and four wood columns supporting the roof above the porch, refer to photo 48. The porch and stairs were reconstructed eight to ten years ago.

Front wood porch and stairs.
