North Kingstown Town Hall & Annex

Building Improvements Feasibility Study 2016

Prepared By:
Aharonian & Associates, Inc.
310 George Washington Hwy
Smithfield, RI 02917

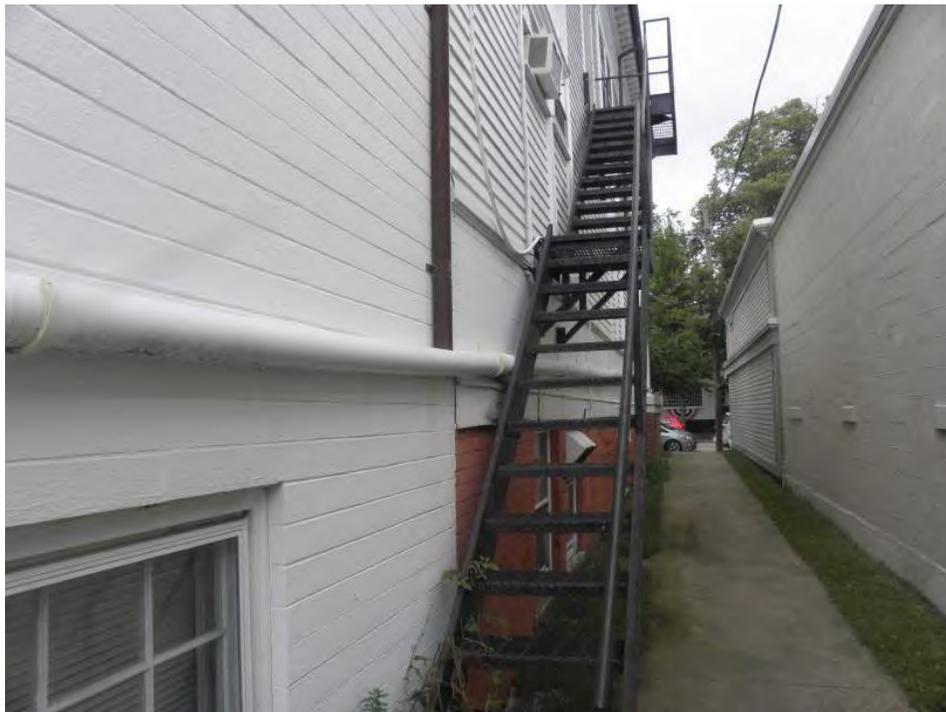
Photo 49

There is a steel fire escape from the second floor to grade on the north side of the building, refer to photo 49.

Steel fire escape on north side of the building.

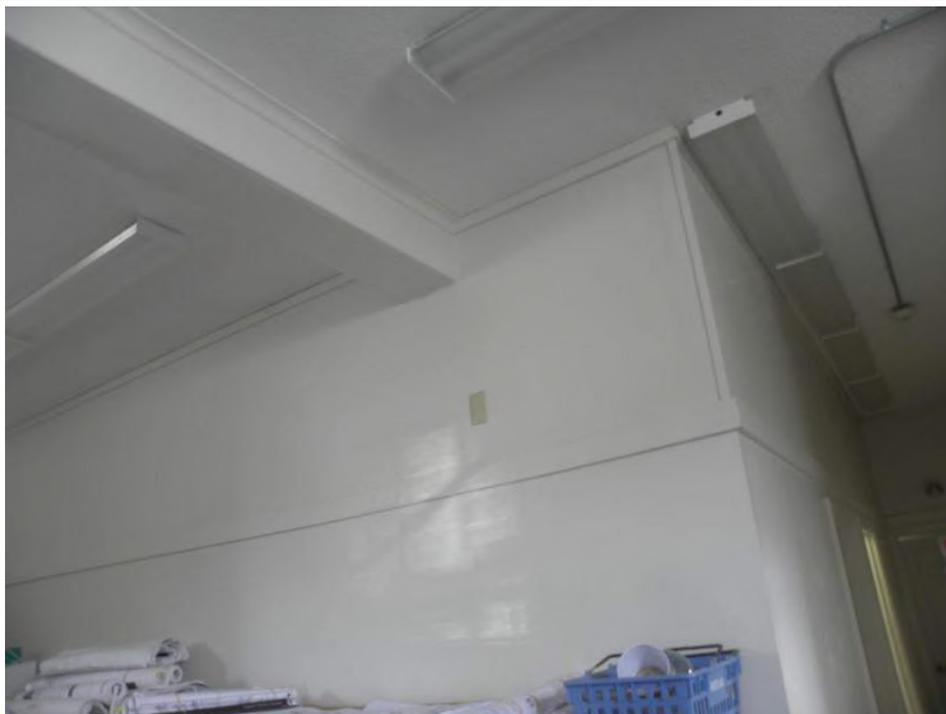
Photo 59

Inside finishes of original building, in good condition.

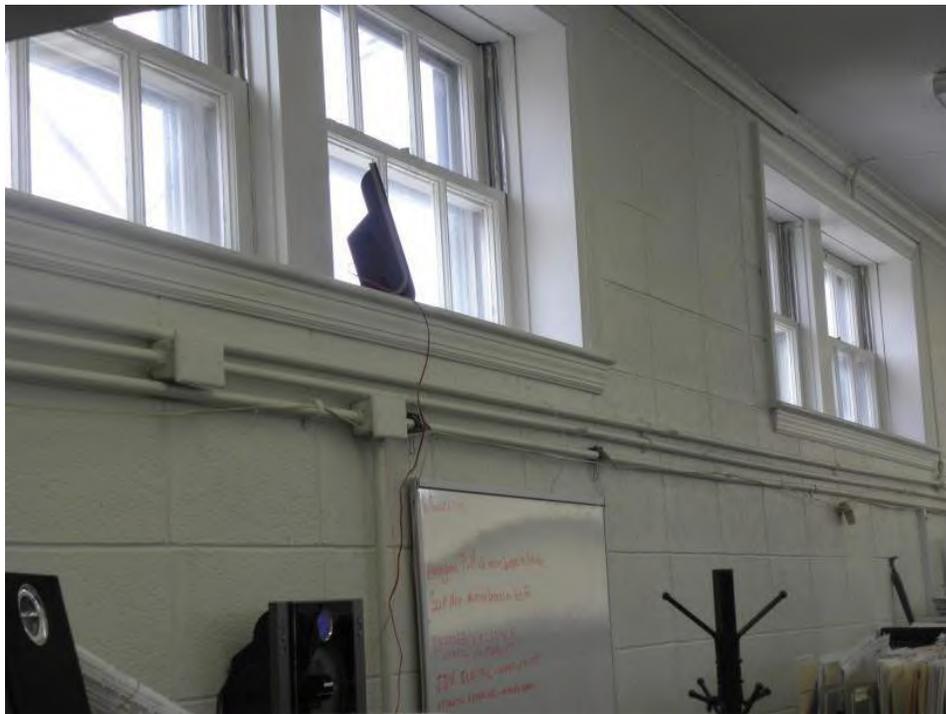
Photo 60

Finishes in rear addition, in good condition.

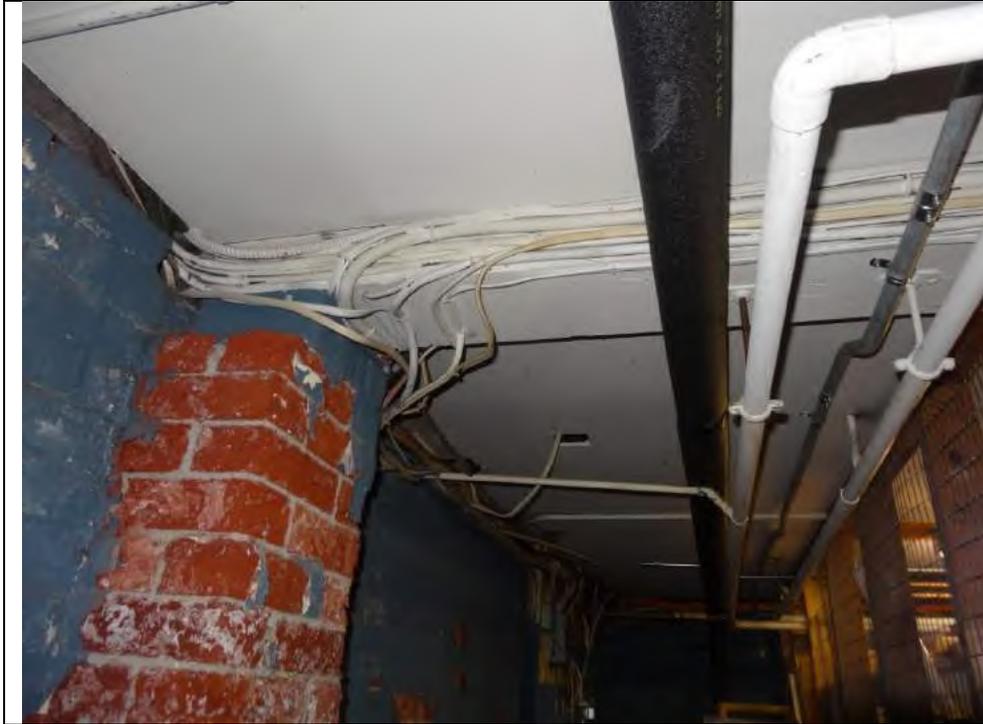
Photo 1

During the review of the existing electrical service it was noted that the service was single phase overhead from a pole on Brown Street. The entry location was at the Northwest corner of the building, penetrating the north wall where the main breaker is located in the basement. The main breaker is a single phase 200 Amp that feeds the building. Additional circuit breakers are fed off this main breaker. It was noted that the clearances in front of the panels were not to code. The circuit breakers that were noted in the basement service the basement and first floor as well as feeding branch circuit breaker panels on the first and second floors. The additional panel on the first floor is located in the storage room behind the room with the large copy printer. The second panel is located on the second floor behind the staff assistant in the office located in front of the town planners office. The majority of the existing wiring observed was Romex and no wire was shielded or in conduit. Refer to photos 1 and 2.

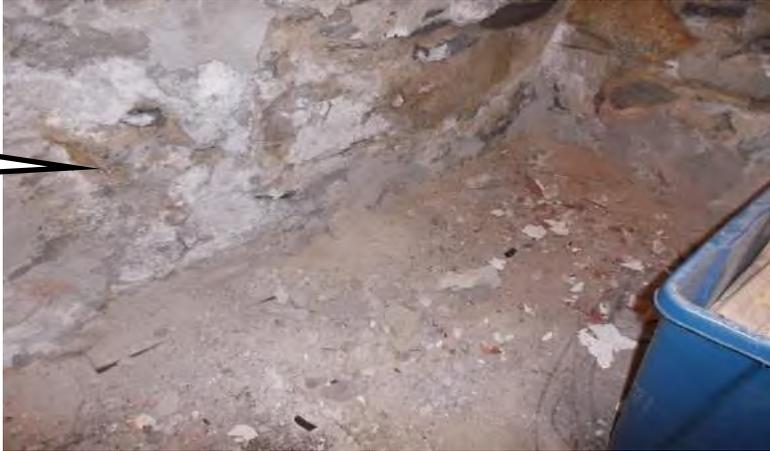
Plaster falling from foundation wall where water had entered

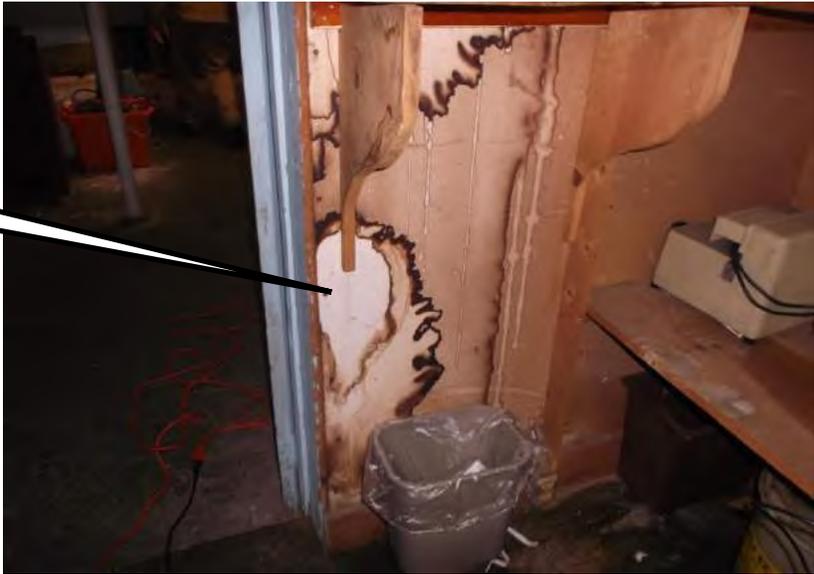
Water stain

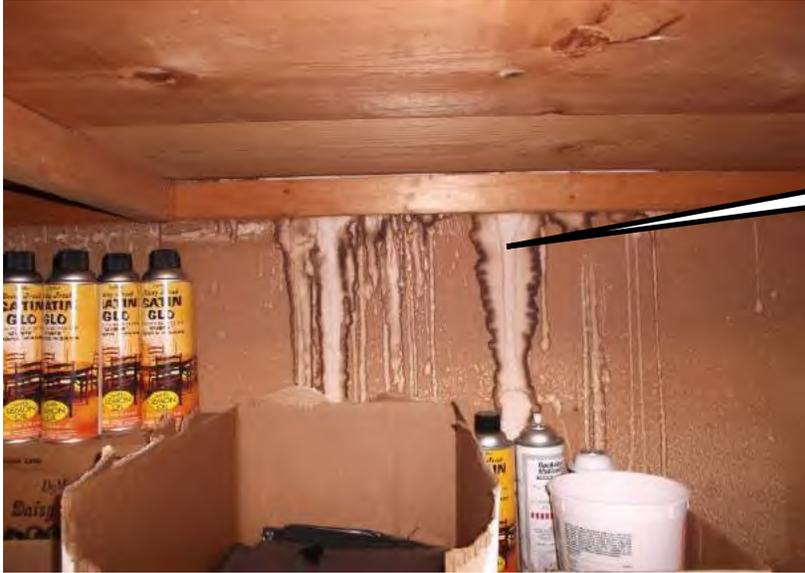
More water stains

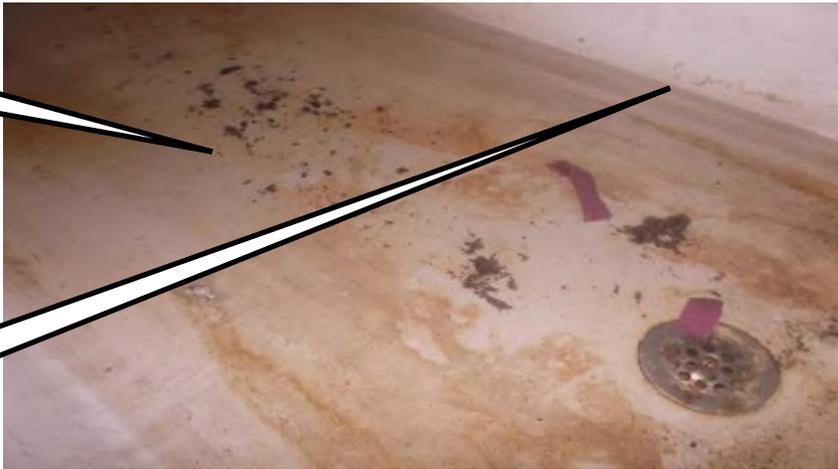
Stagnant water in tub

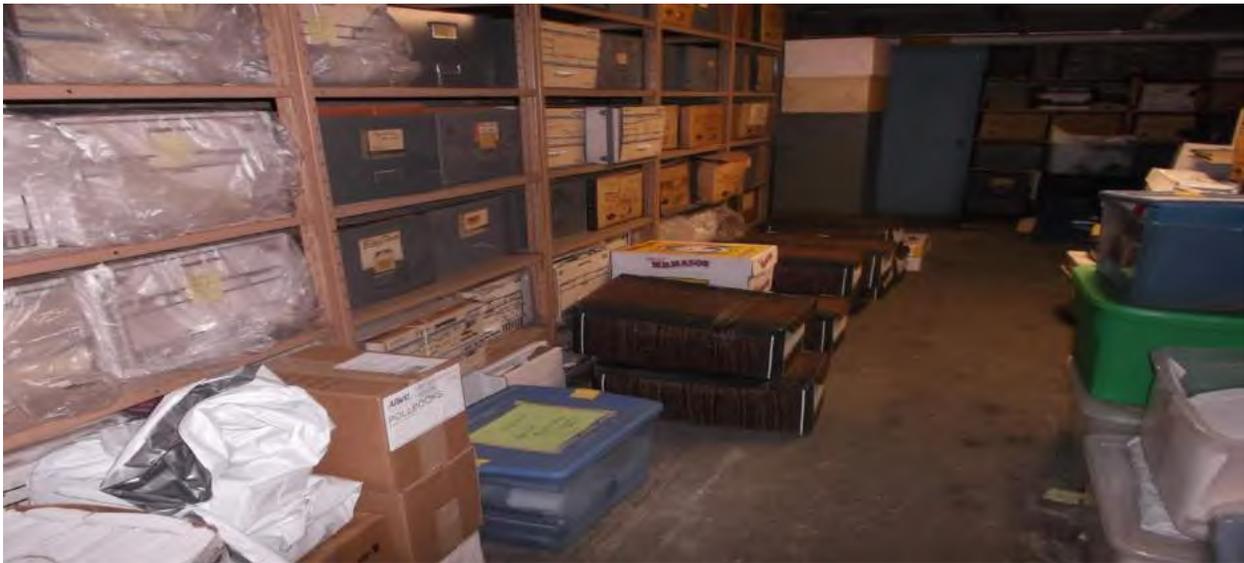
Water level

2. A dehumidifier had been placed in the basement to reduce the airborne moisture. It contained an over flow tube (into the bathtub) but the humidifier's reservoir was full of stagnant water.

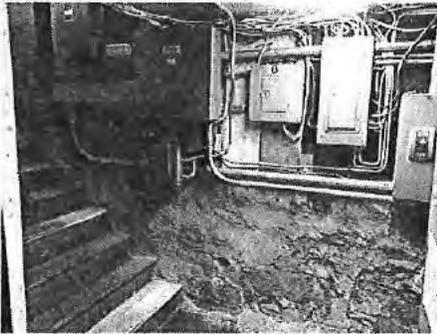
2 Electrical Service

The electrical service is located in an egress stair.

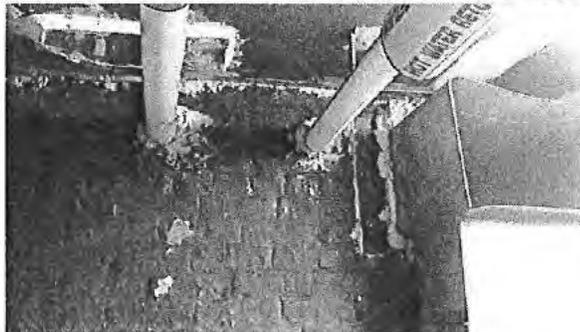
3 Fire Wall Penetrations

The required fire separation wall at the boiler room has multiple Penetrations.

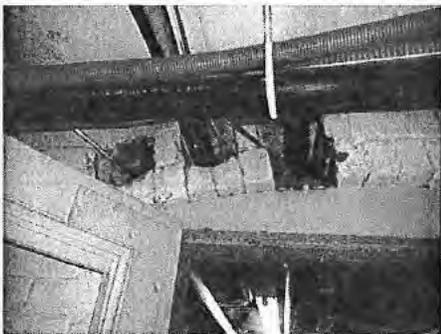
5 Structural Header between exit access hall and storage room

The structural header has been compromised by penetrating utility raceways

5. Structural header between Exit Access Hall & Storage Room				6,000.00	Masonry Repair	
6. Egress Access in Basement- Stairs & Walking Services				0.00	Move Files
